INSPECTION GROUP

2008 Katy New Construction

PROPERTY INSPECTION REPORT

Concerning: 2008 New Construction, Katy, Tx. 77494
(Address or Other Identification of Inspected Property)

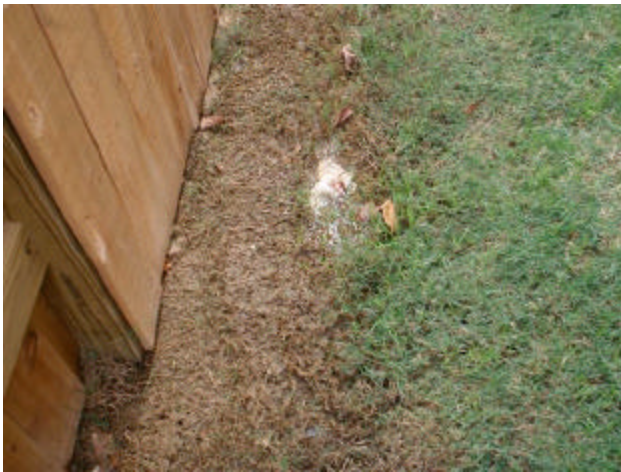
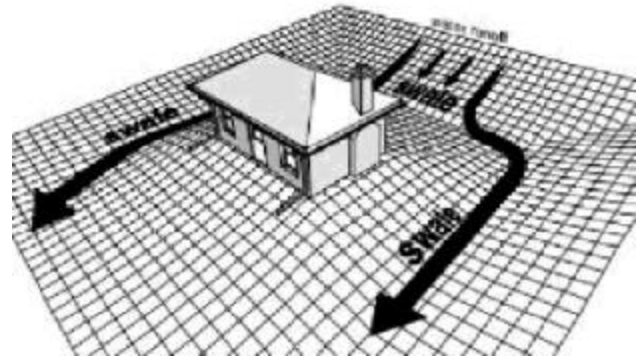
Drainage swale is not continuous, at sides The drainage swale must be kept clear and continuously sloped in order to drain water properly. Standing water observed at each side of home.

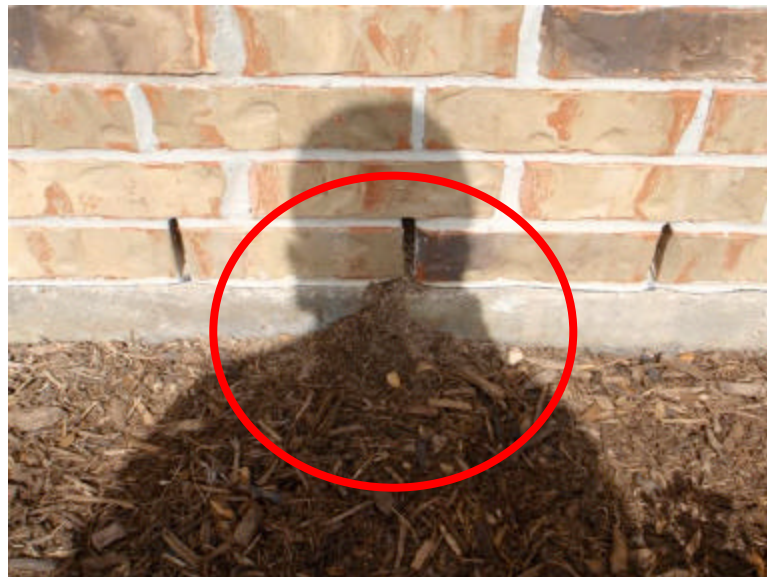
Ants entering house at brick weep holes, use insecticide treatment, do not seal up weep holes.

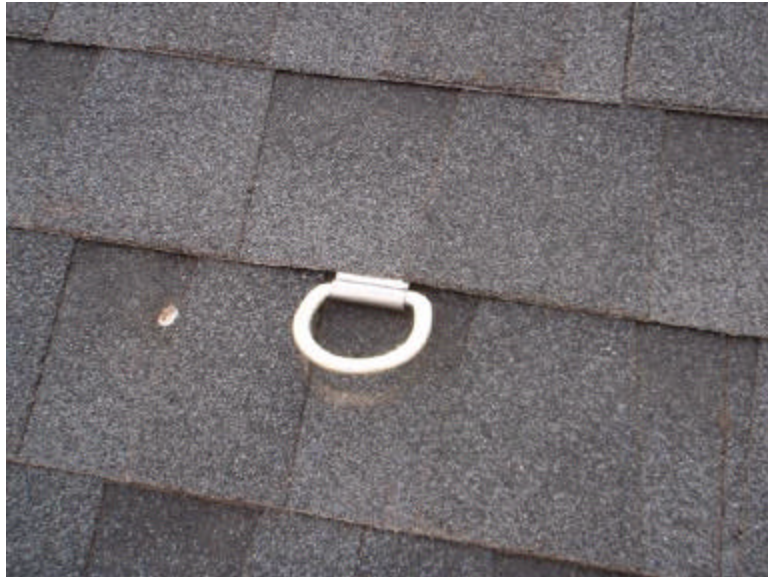
Anchor strap observed near roof peak – recommend leaving strap in place for future use.

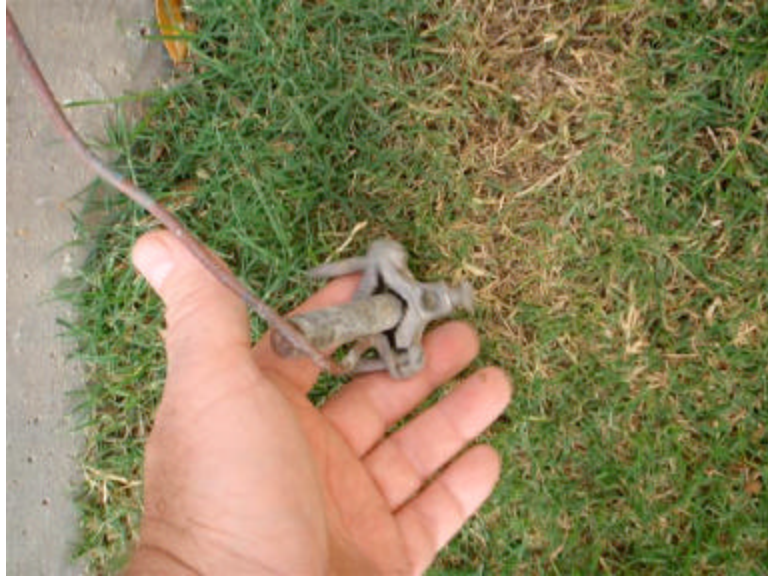
Ground clamp and/or wire not secured to ground rod below service meter.

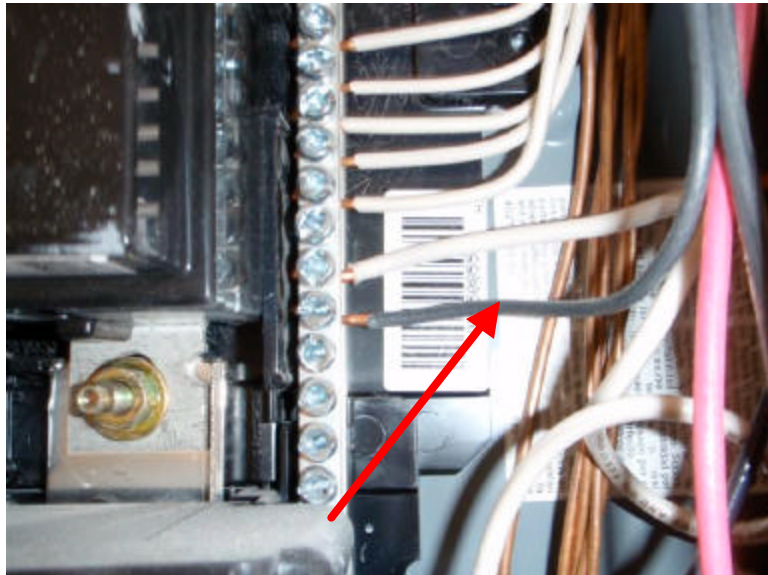
Wrong colored wire installed at neutral bus bar – grounded conductors should be predominantly white in color.

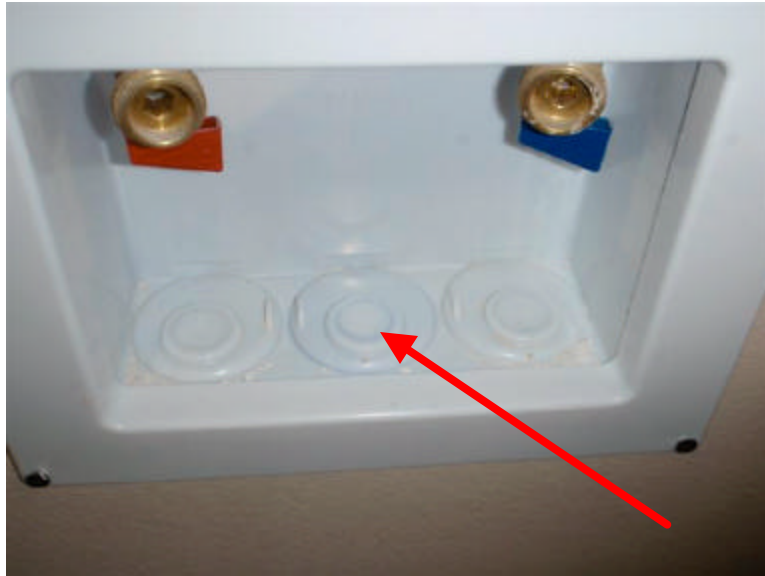
Water tight box knock out for washing machine drain line has not been removed.

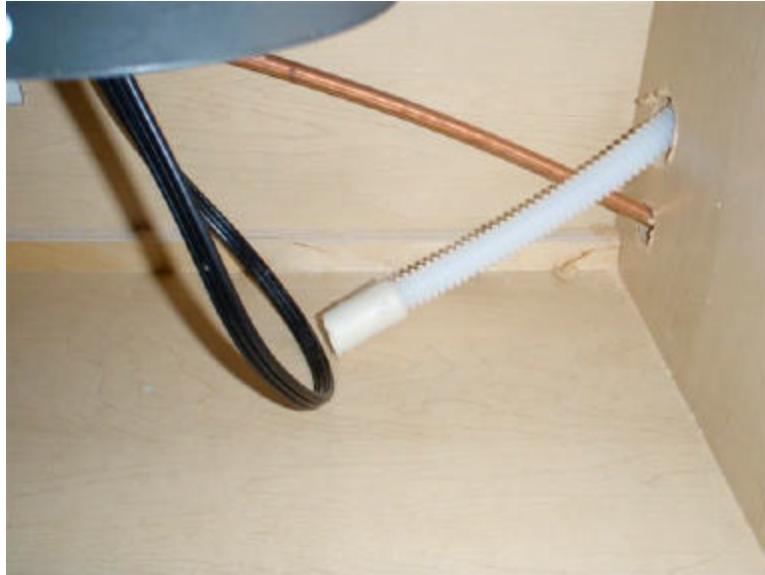
A. Dishwasher
 Comments:
 Dishwashing unit was not completely installed at time of unit – unable to operate or inspect.
