Property Inspection Report # 090324awN

**New Construction Collegeview Area,
Houston, TX**

PROPERTY INSPECTION REPORT

Concerning: New Construction College View area, Houston, Texas
77005
(Address or Other Identification of Inspected Property)

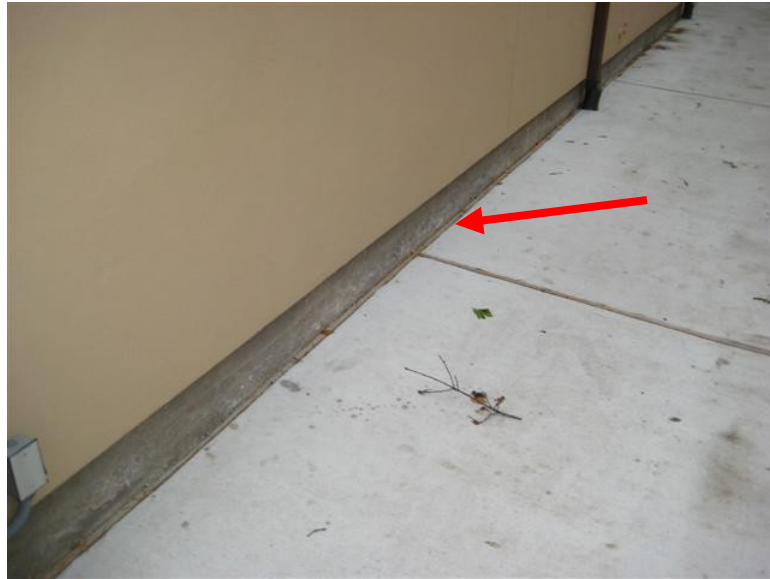
Wood form board(s) around foundation are considered a conducive condition for wood destroying insect activity.

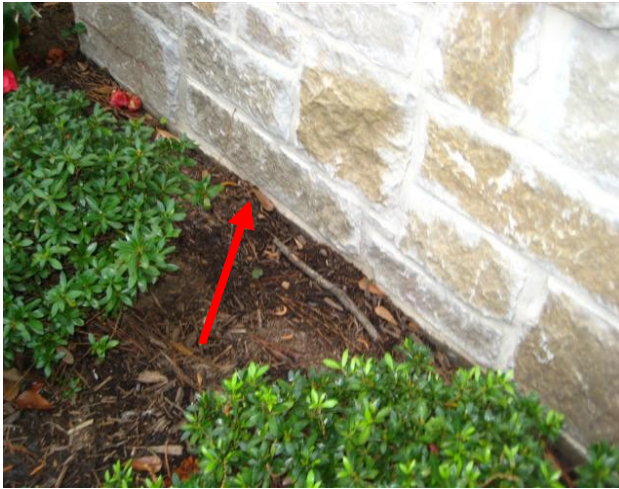
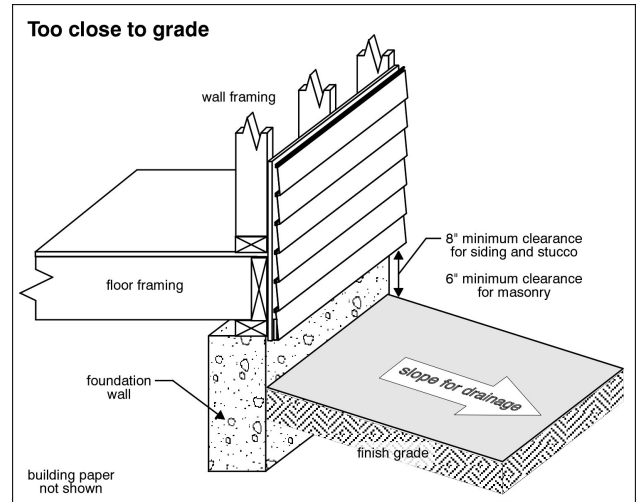
Soil level too high around areas with brick/stone siding at front flower beds. Common industry practice requires a clearance of at least 4 inches from bottom of brick/stone veneer to soil. High soil level near brick/stone siding promotes wood rot and is considered a conducive condition to termite activity and water penetration.

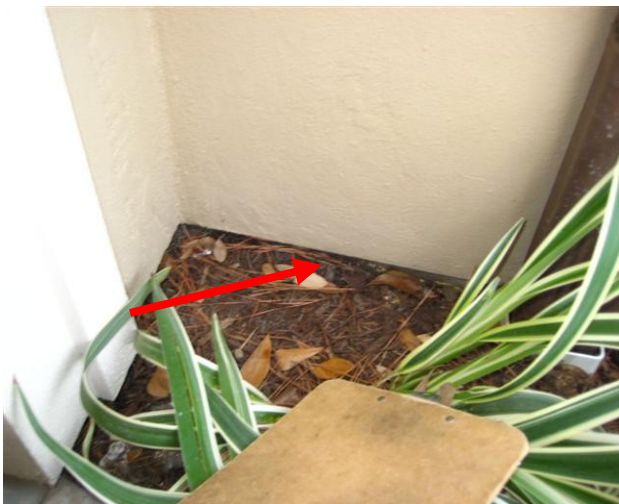
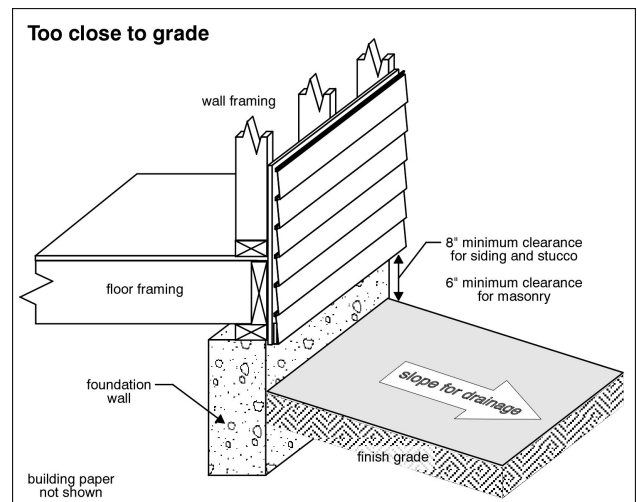
Soil level too high around areas with stucco siding at flower beds and sides of house. Common industry practice requires a clearance of at least 6-8 inches from bottom of stucco to soil. High soil level near stucco siding promotes wood rot and is considered a conducive condition to termite activity and water penetration.

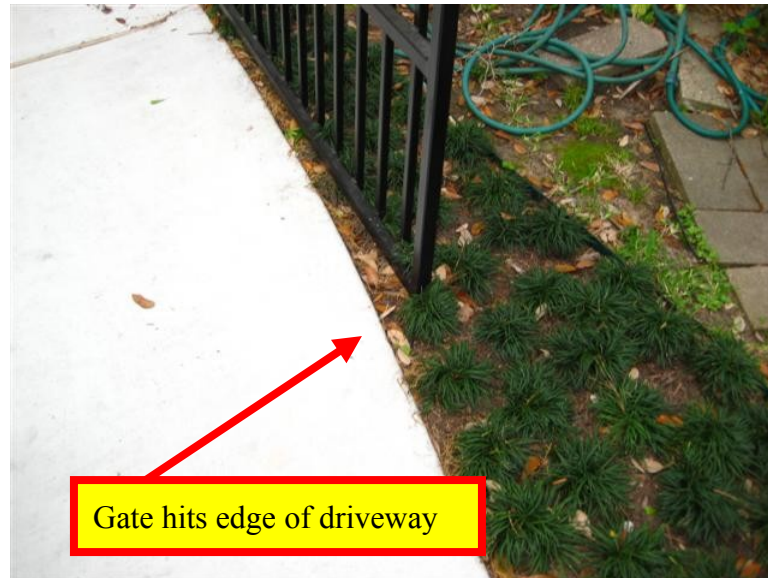
Driveway gate needs adjustment; gate hits edge of driveway when opening/closing.

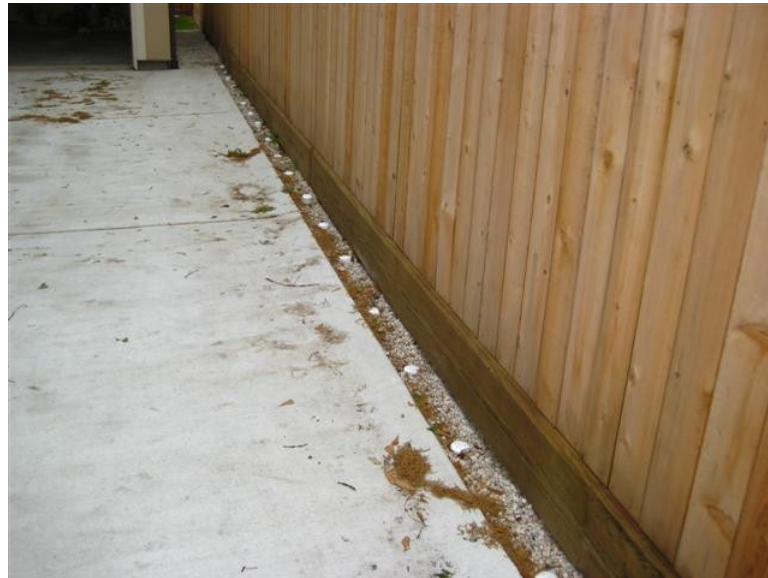
Buyer's note: Per builder, a tree root aeration system has been installed along the west side of driveway per the requirements of the city. Aeration system is for the neighbor's tree. Recommend inquiry of city/builder if this system requires maintenance.

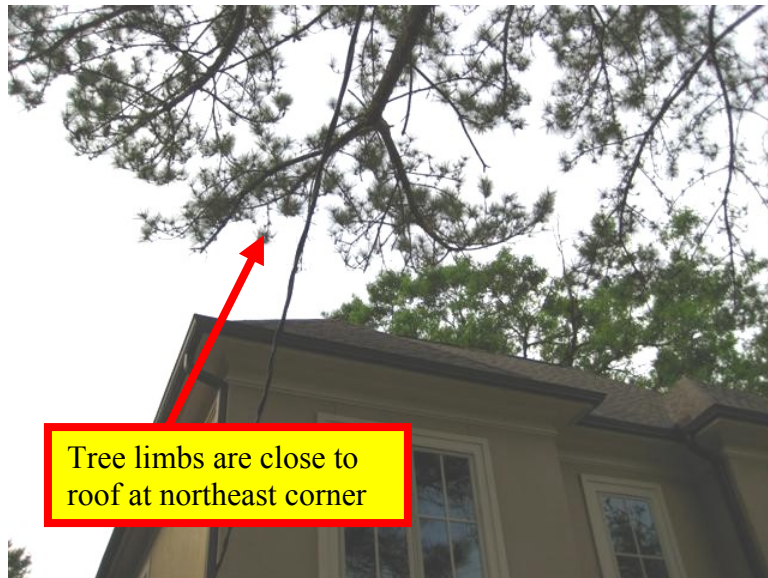
Buyer's note; Keep leaves from collecting on roof, especially in valleys and keep tree limbs away from roof to prevent damage to shingles.

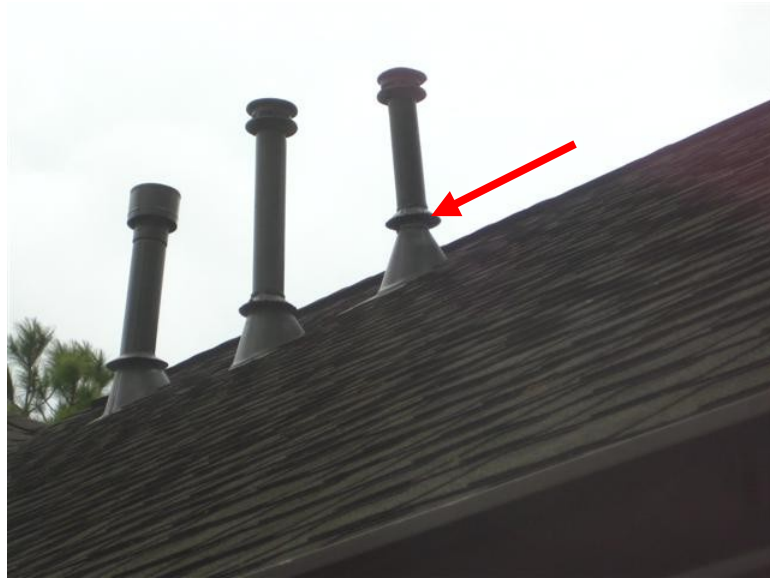
Storm collar not properly positioned on water heater vent pipe; daylight visible around vent pipe in attic.

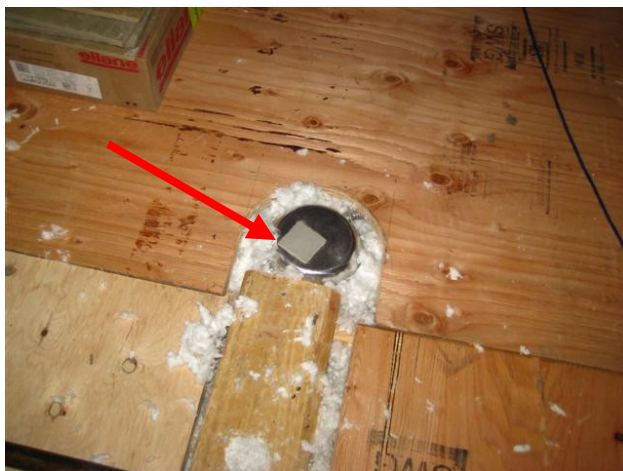
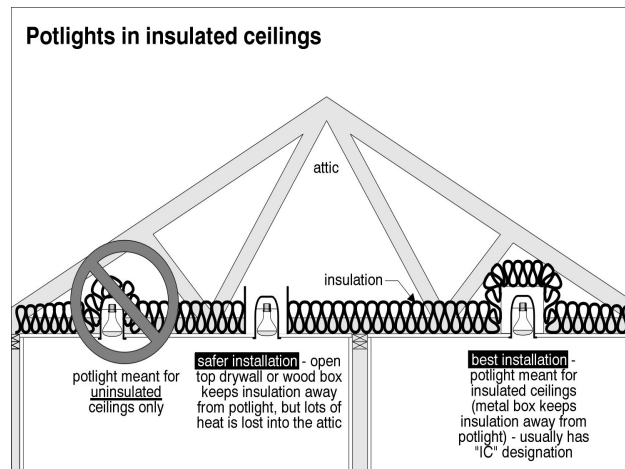
Ensure insulation is maintained a minimum of 3 inches and wood a minimum of 1 inch from around all recessed lights to reduce possible fire hazard.

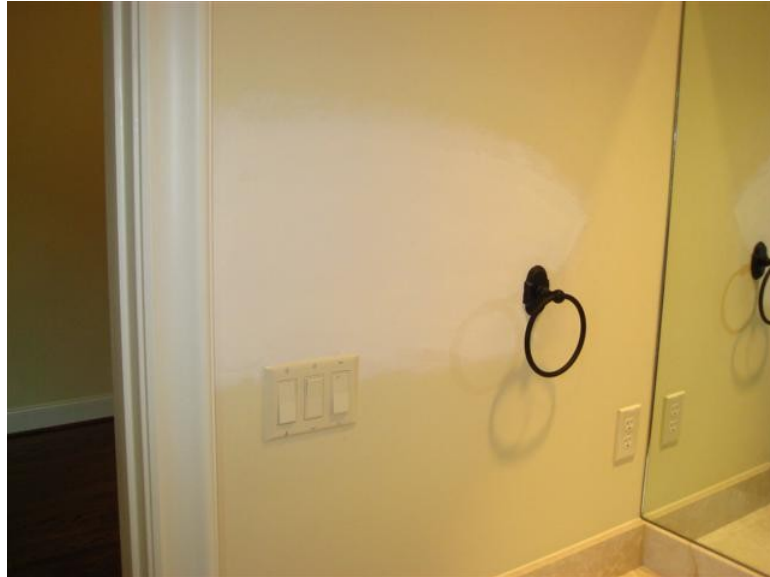
Unpainted repair observed to bathroom wall at northeast bath.

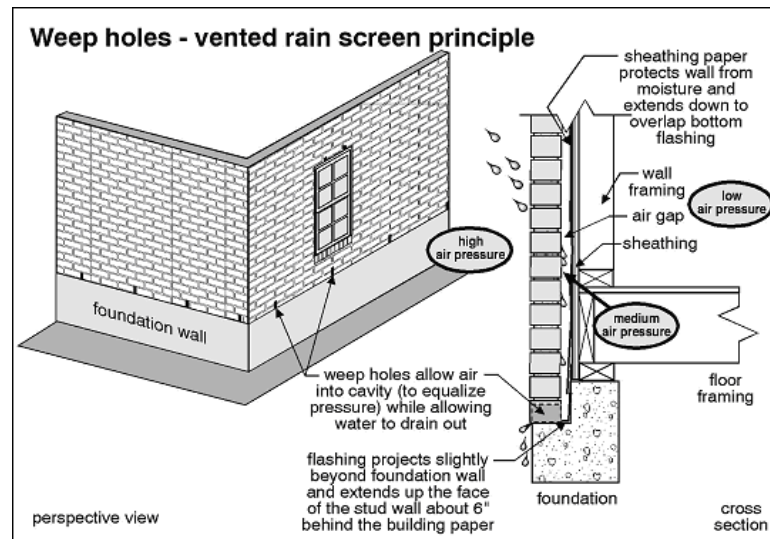
Observed weep holes at bottom of brick/stone wall (front yard) are blocked with debris and/or have been sealed over. Weep holes are needed to allow for proper drying of the wall cavity. Recommend clearing any blocked weep holes.

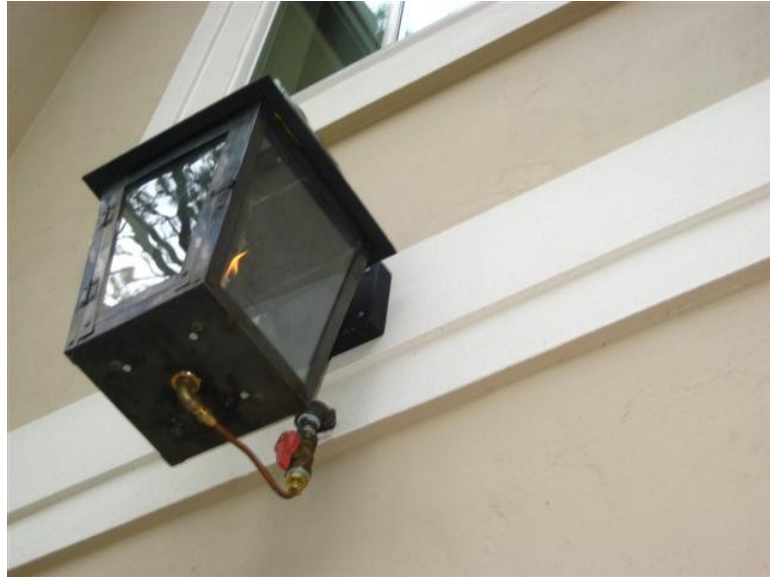
Gas lantern over front door needs caulking/sealing around edges to prevent water entry.

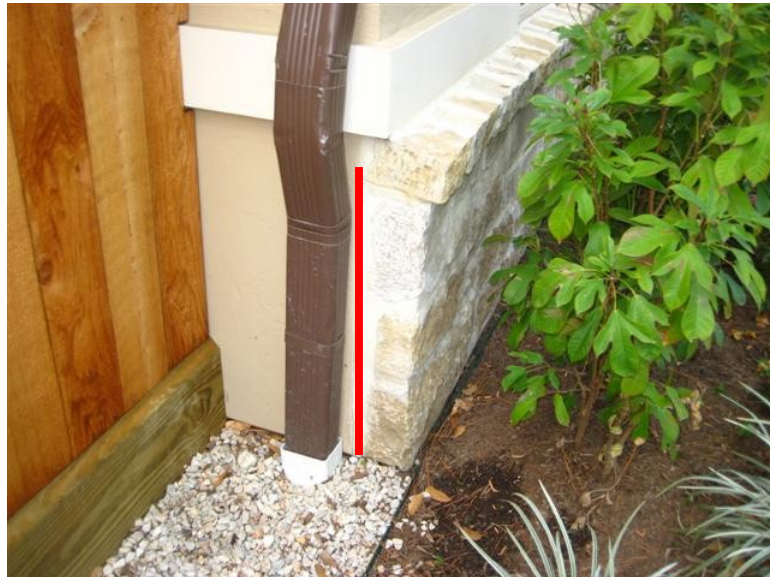
Vertical crack observed at northeast corner. Area needs to be sealed to prevent water entry.

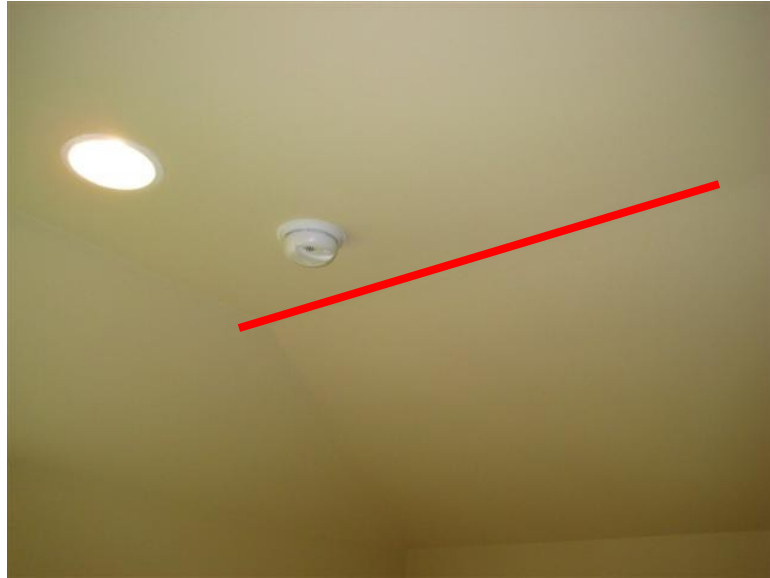
Hairline crack observed over back stairway.

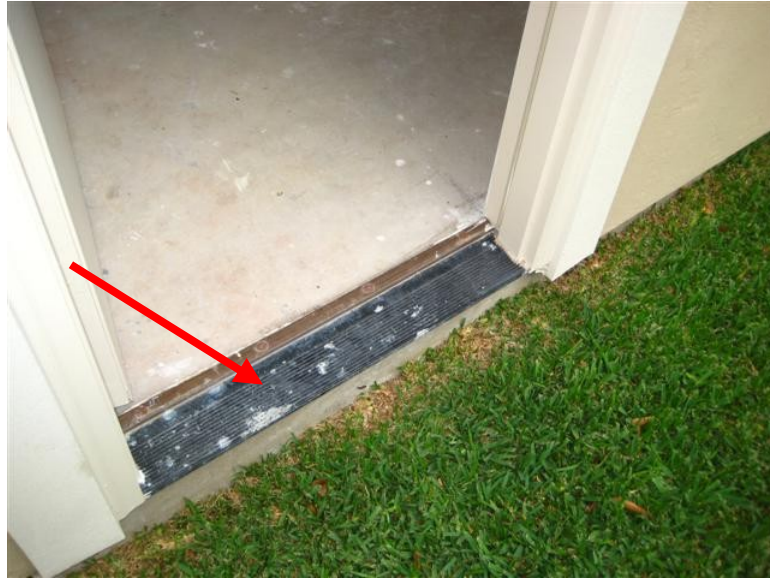
Improper threshold used on exterior door (back garage door) without roof overhang protection from wind driven rains will probably result in water damage from intermittent water entry. Recommend replacement with metal type threshold with rain water channels that directs water back to exterior.

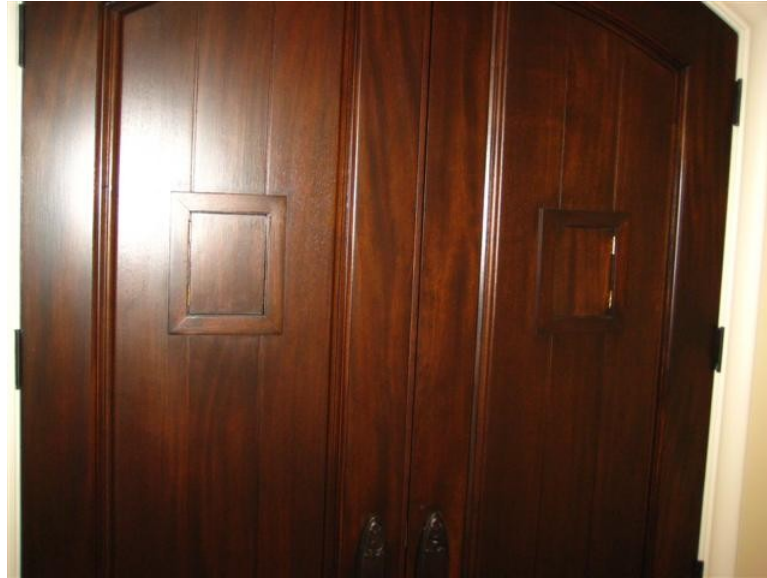
Unable to open small doors on front door from the inside.

Recommend adding an interior lock/latch to small doors on front door. Doors can be pushed open from the outside to view interior of house.

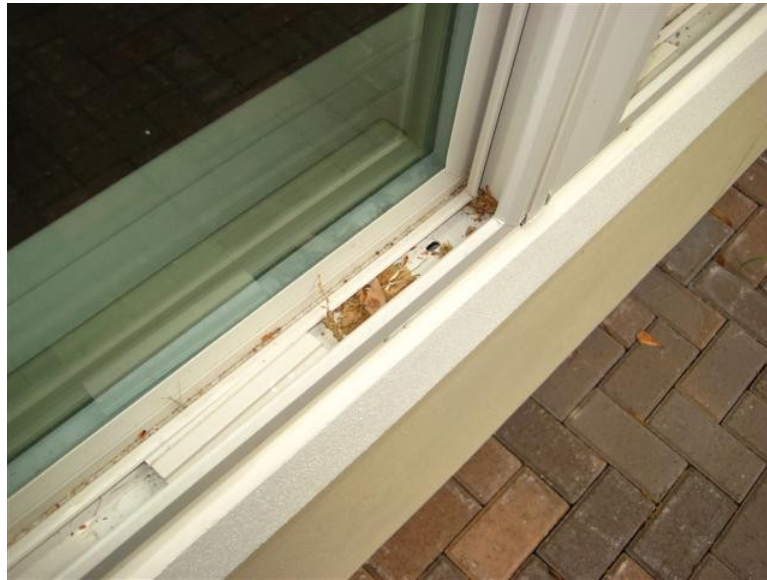
Recommend periodic cleaning of drainage track on all windows. Drainage hole covers needs to be positioned over drain holes to prevent debris build up.

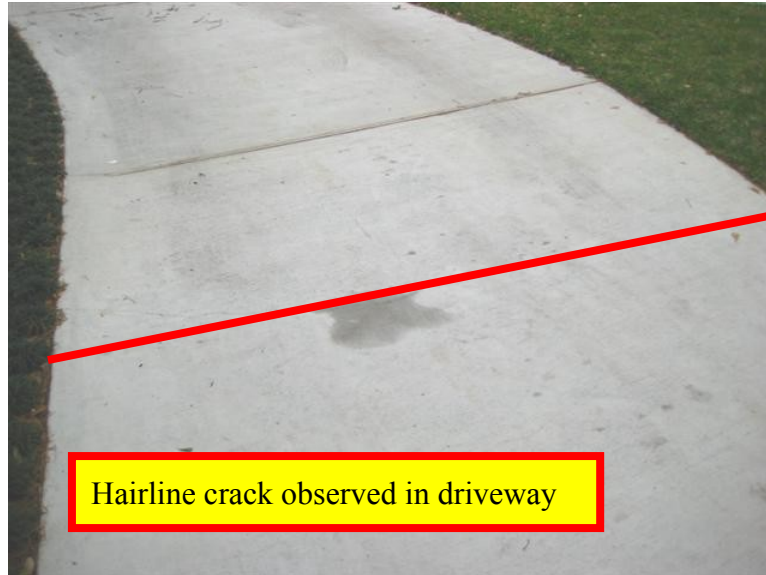
Cracks in driveway and/or garage concrete observed, typical.

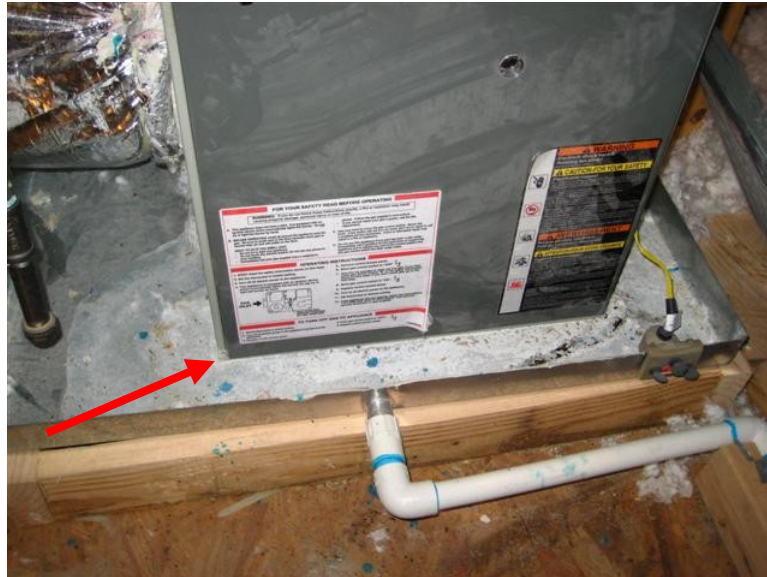
Both furnace units sit directly on secondary drain pans. Manufacturer's installation instructions call for units to be elevated off of drain pans.

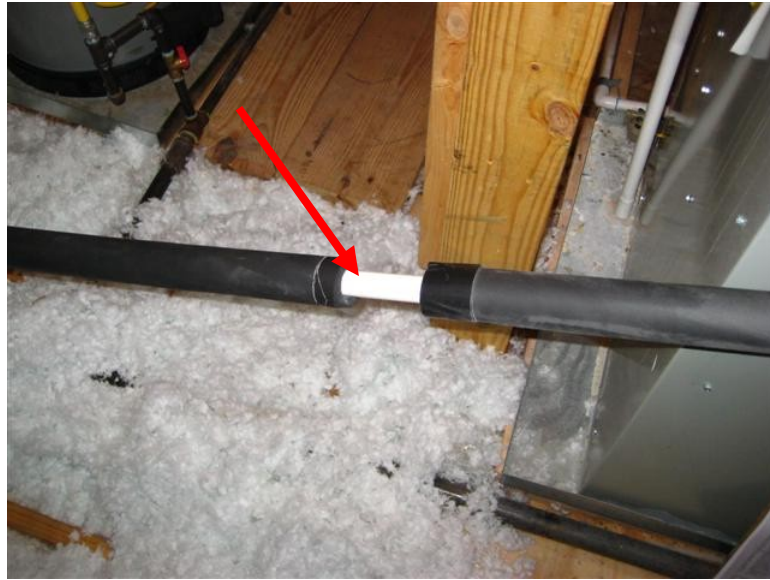
Primary drain line should insulated along entire length in attic to prevent warm attic air condensing on cool drain line and dripping condensation. 1st floor.

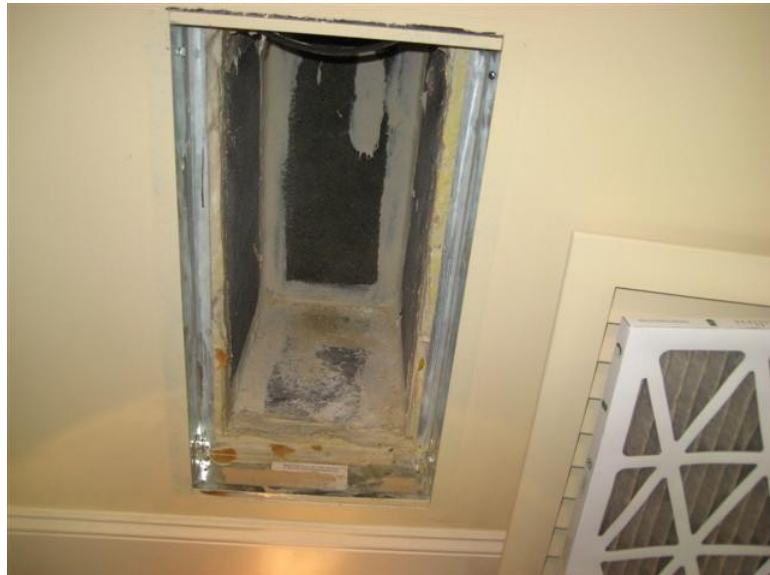
Return air chases are dirty, need cleaning.

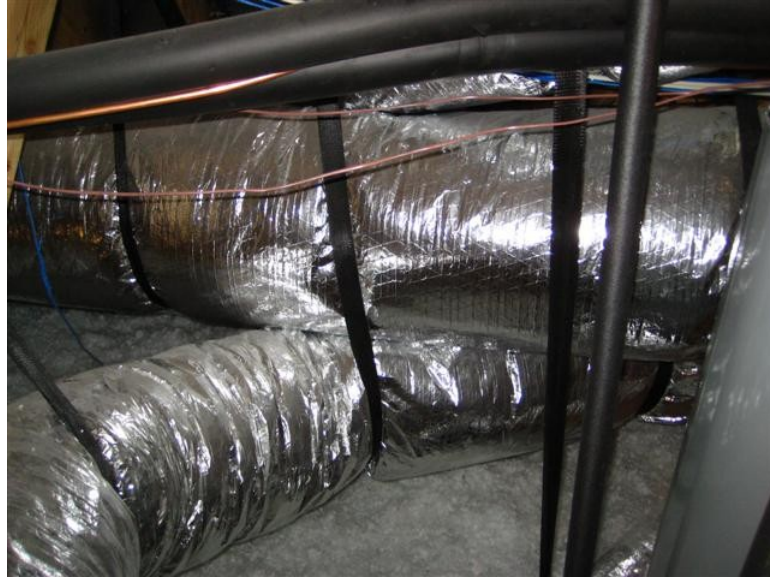
Observed several / multiple areas in attic where flex duct touch and are missing required 1" clearance from other ducts to prevent condensation between ducts that touch.

Recommend general maintenance to flex ducts in attic, Re-support where needed, seal/tape minor air leaks, repair torn/damaged vapor seal, etc..

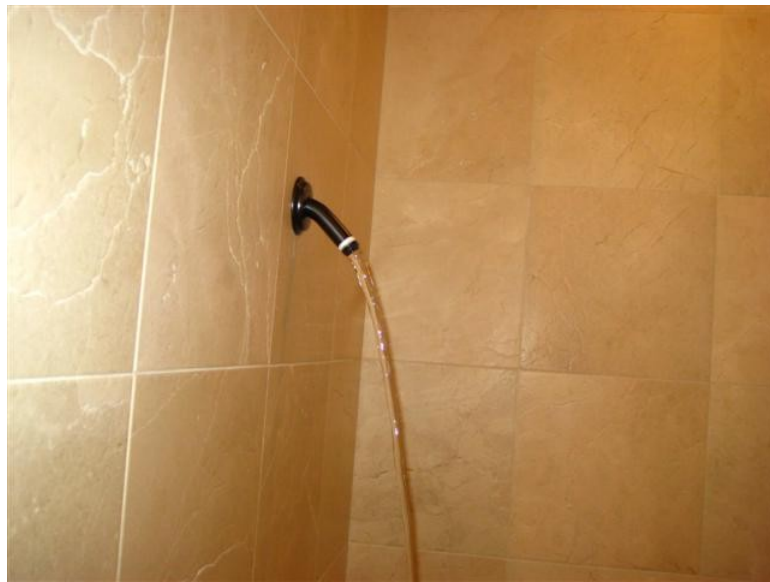
Multiple shower head(s) missing; west and master baths.

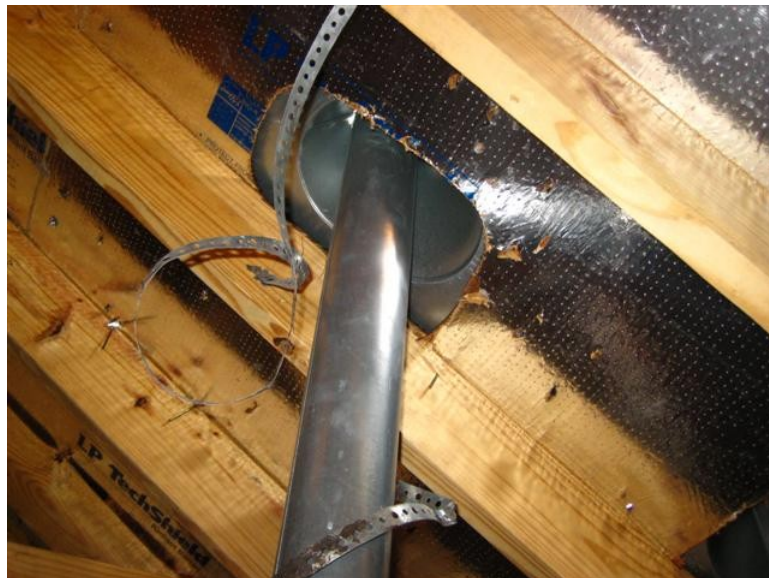
Vent pipe(s) is (are) not properly secured (strapped) in place.

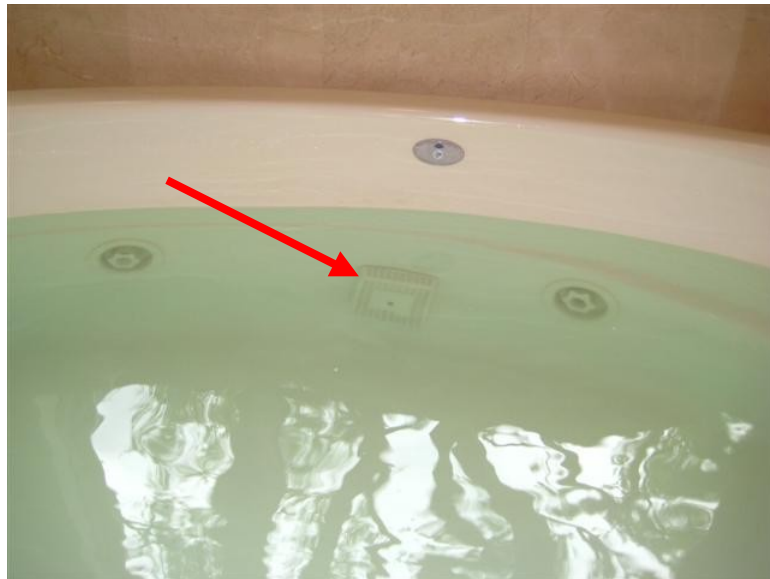
Screen on water intake unit is crooked.

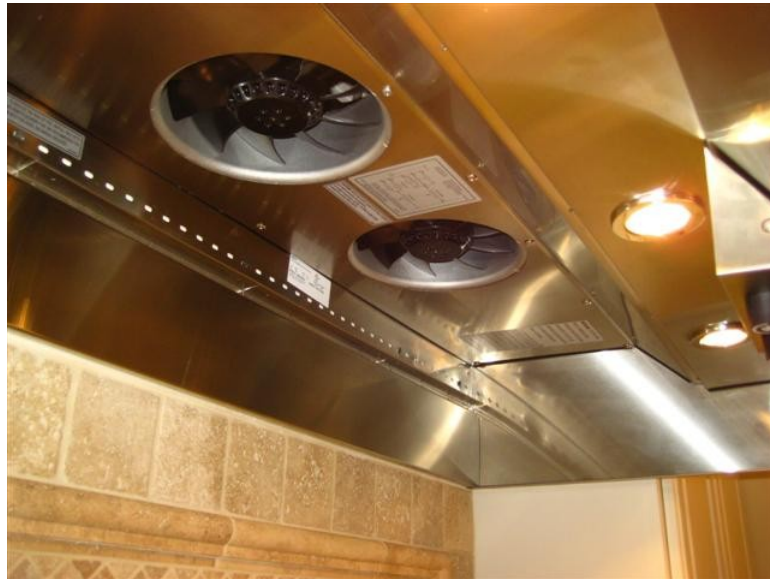
Screens are missing over exhaust fans.

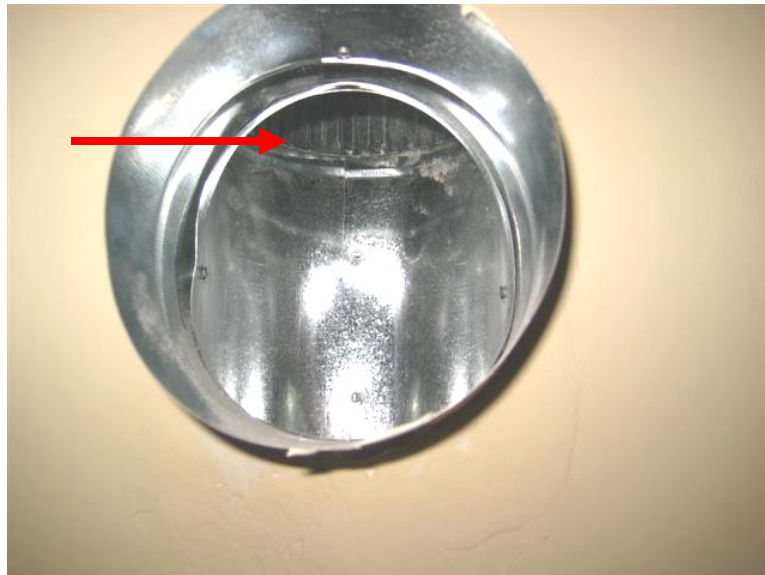
Vent pipe connection(s) improper, inside out, will have tendency to trap combustionable lint.

Recommend periodic cleaning dryer venting duct of lint to reduce risk of fire..

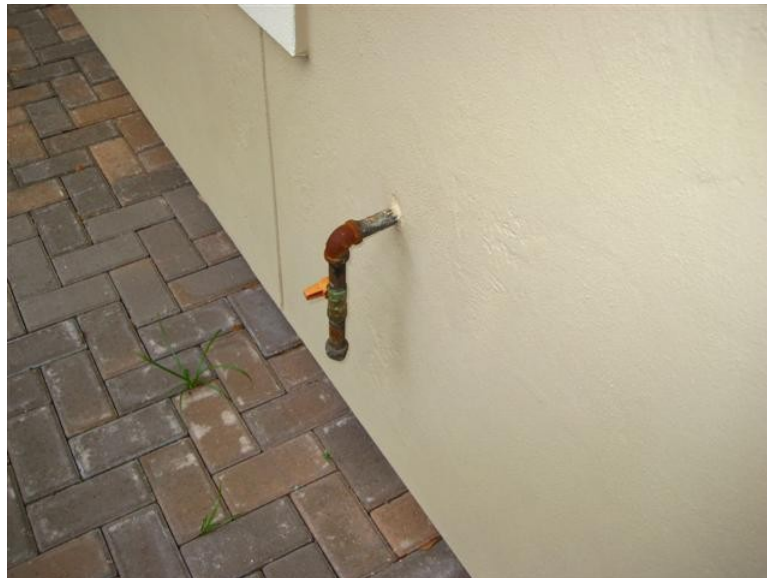
Gas line at back patio is rusting.
