# ***PROPERTY INSPECTION REPORT***

**Concerning:** 1955 Inside 610 Loop, Houston, Texas 77025  
(Address or Other Identification of Inspected Property)

**By:** Mike Johnson TREC #6389  
(Name and License Number of Inspector)

March 24, 2009  
(Date)

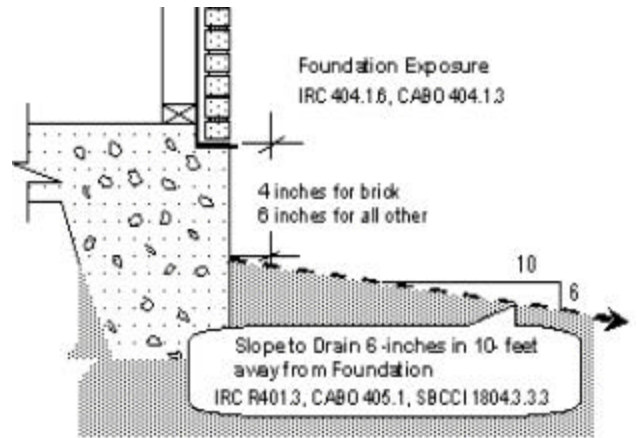
Soil grade and drainage patterns around some areas of house do not appear to properly direct water away from foundation to aid in controlling runoff water and could cause differential movement of the foundation or water penetration during heavy rains.

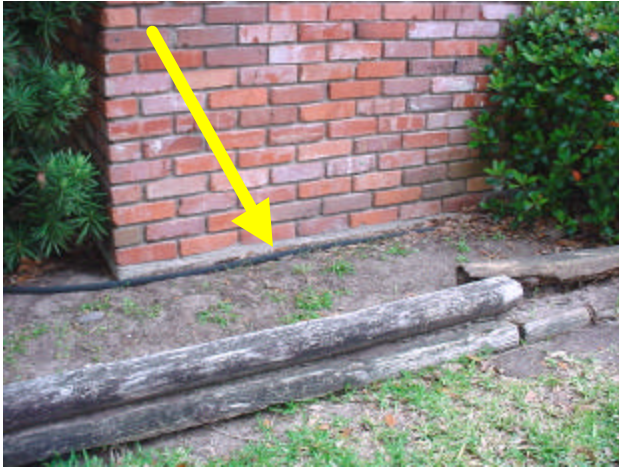
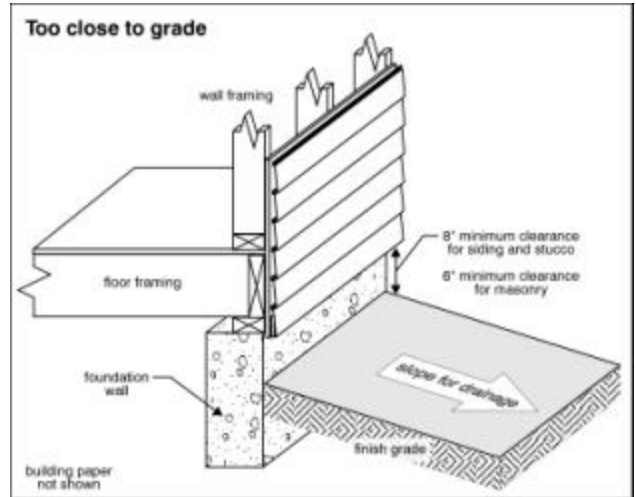
Soil level too high around areas with brick siding at west side. Common industry practice requires a clearance of at least 4 inches from bottom of brick veneer to soil.

High soil level near brick siding promotes wood rot and is considered a conducive condition to termite activity and water penetration.

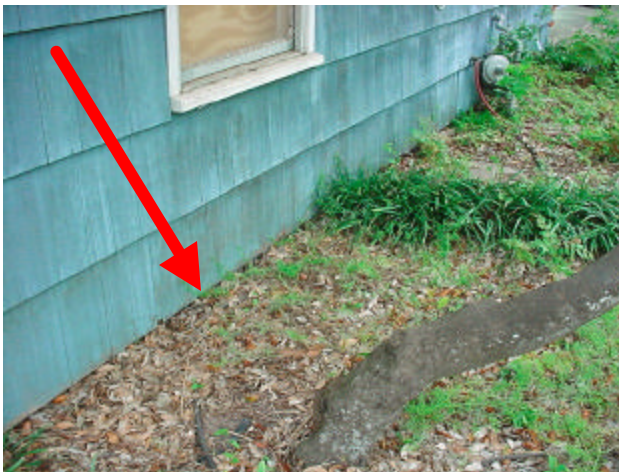
Soil level too high around areas with wood siding. Code and common industry practice requires a clearance of 6-8 inches from bottom of wood veneer to soil. High soil level near wood siding promotes water/termite penetration and wood rot.

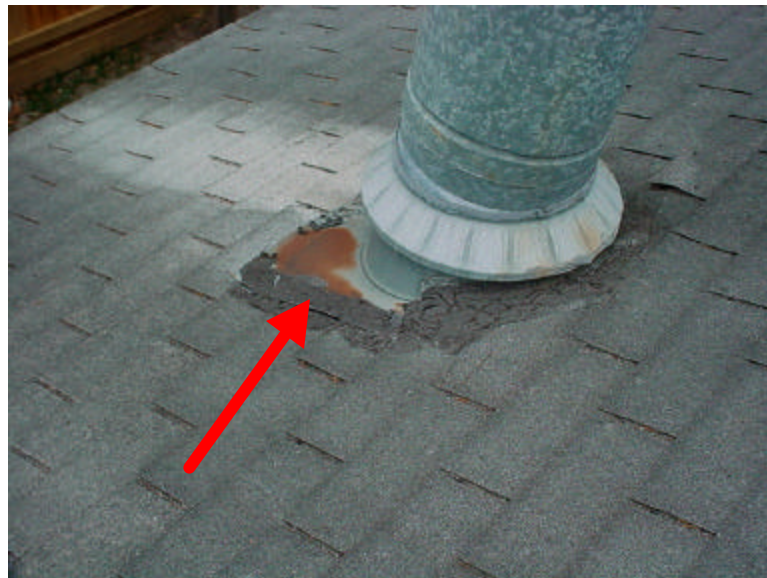
Flashing needs to be sealed / caulked at following location(s); chimney.

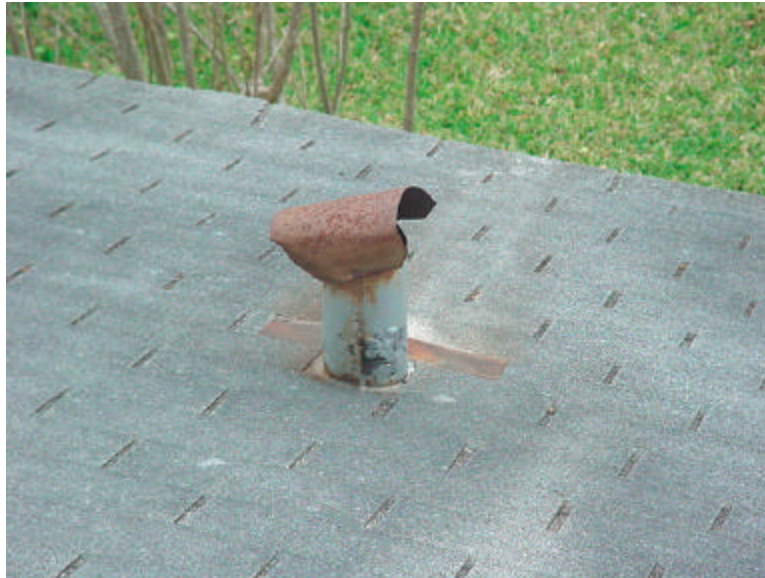
Severely rusted and/or rusted through; several roof penetraions.

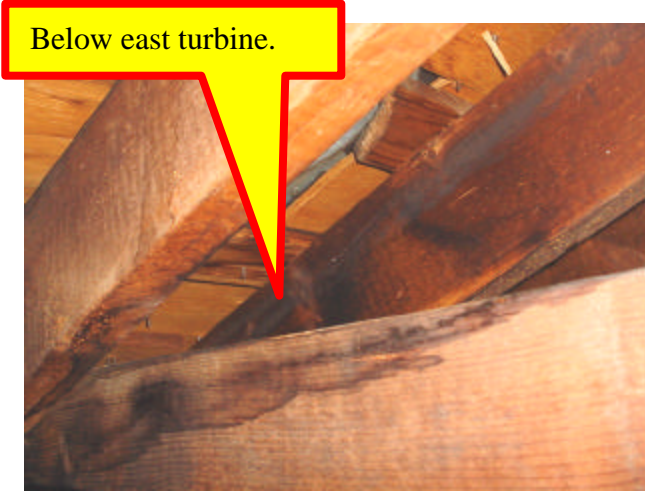
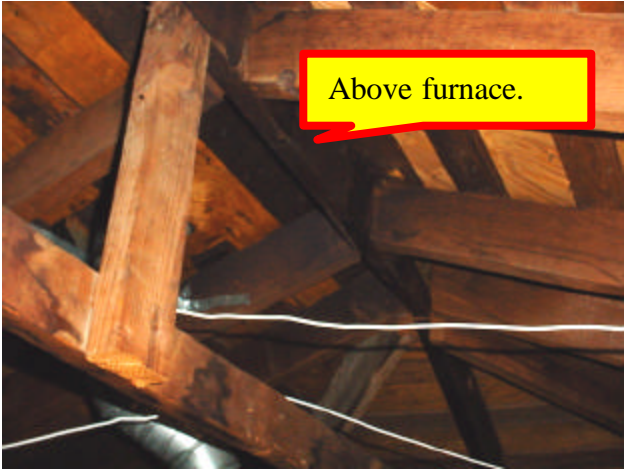
**YES!!, in several areas , including but not limited to: above furnace, below east turbine, and in front soffits.**

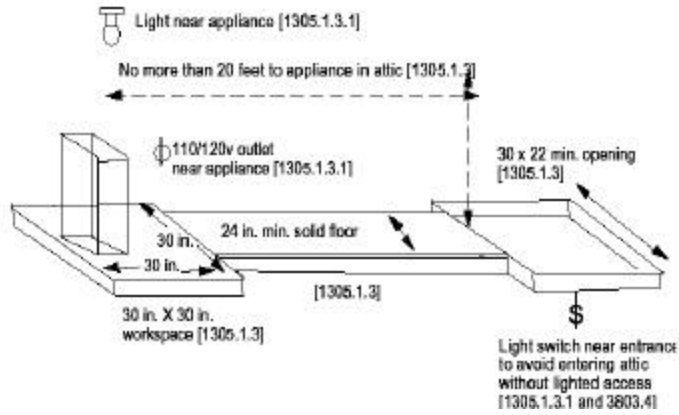
Inadequate attic walkway and/or platform to mechanical equipment in attic. [UMC 908 & CABO 1401.5] requires 30 inch head clearance and a minimum 24 inch wide SOLID (no gaps or obstructions), floor to equipment for servicing and a 30 inch deep solid platform in front of equipment.

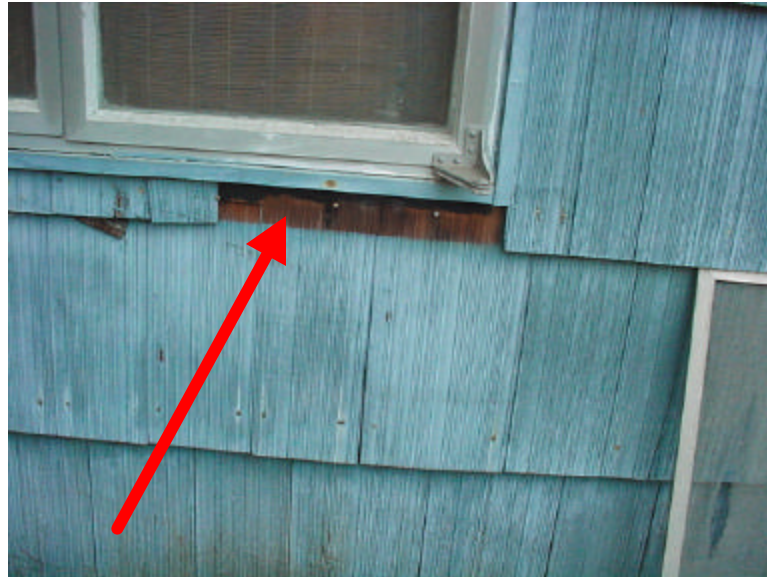
Wood siding observed to be not secured down at one or more areas of house / garage.

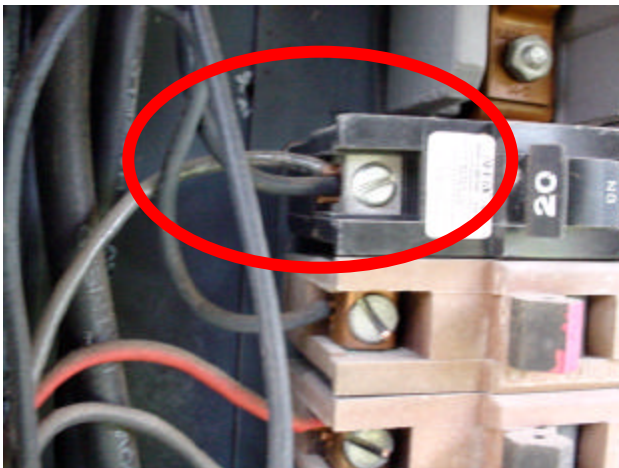
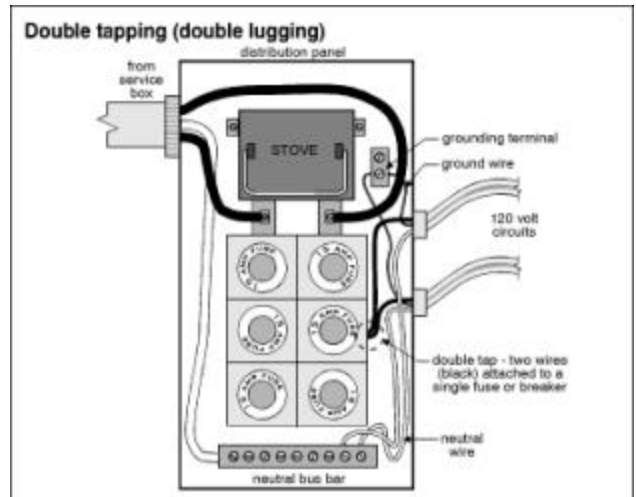
Double ganged breaker(s), [two wires improperly on 1 breaker] observed. "Top left.

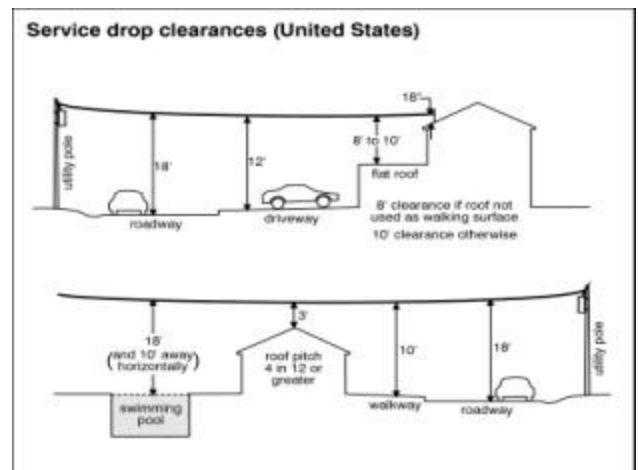
Low elevation of power lines at/near house/garage, Code requires a minimum clearance of 10 feet & 12 feet over walkways and driveways respectively; use caution when near, or have lines raised/buried.

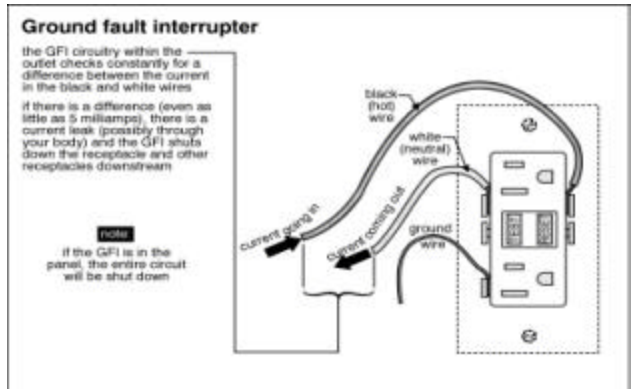
Did not observe GFCI protection of all outlets in required locations, including but not limited to; all bathrooms, all kitchen counter top outlets, wet bar locations, all exterior outlets, in garage, etc. This condition is a recognized safety hazard and is in need of repair.

One or more outlets in the following locations were not protected:

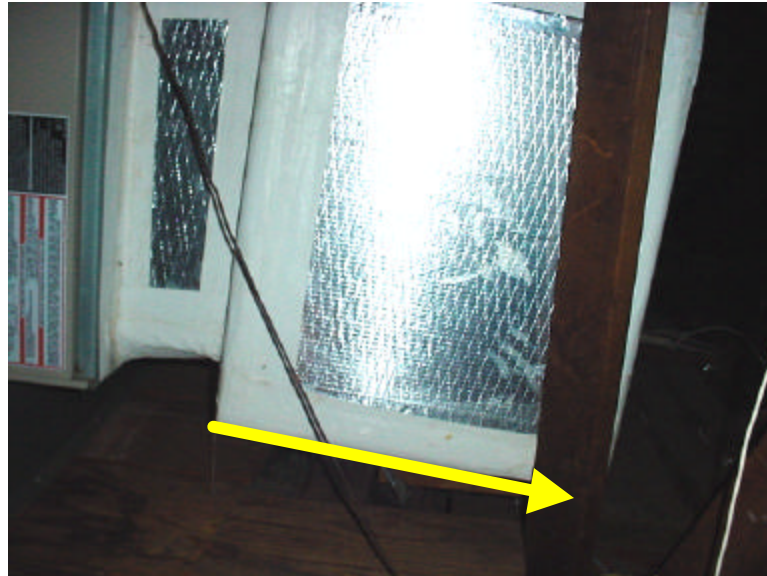
Improper plenum support.

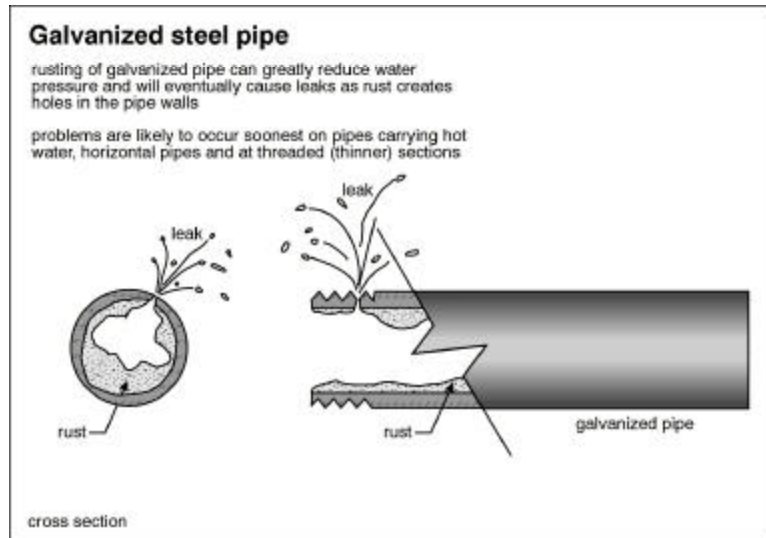
*Water supply piping observed to be predominantly galvanized*

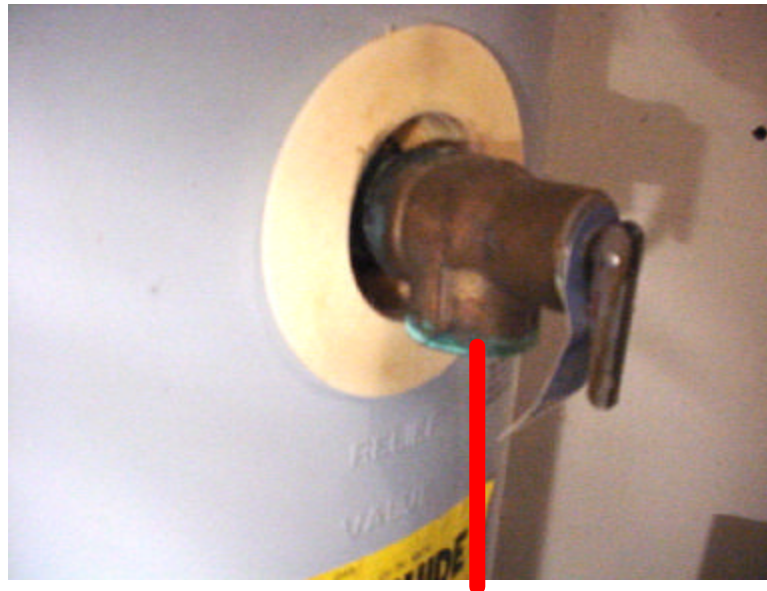
**Drain line is not present. This condition is considered a recognized safety hazard**

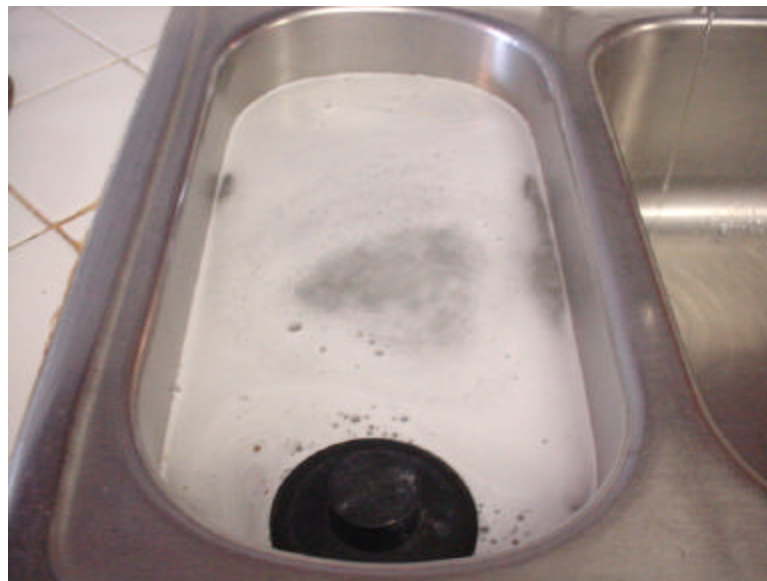
Drain line needs to be elevated above side inlet of disposal to underside of countertop to prevent debris and gray water from draining down line from disposal and back into dishwasher.

Unit backflows into garbage disposal sink.
