FIG Services LLC d/b/a FOX INSPECTION GROUP
 Property Inspection Report # 120410mj
 11227 Endicott Lane Houston, TX 77035
 (Office) 713.723-3330 (Email) office@foxinspectiongroup.com

PROPERTY INSPECTION REPORT

April 10, 2012
(Date)

Description: PREPOUR INSPECTION OF SLAB ONLY. As I was leaving some workers arrived and I got them to do some corrections as time is of the essence. Foundation to be poured in 13 hours of when I left. Workers spoke only Spanish, I speak English.

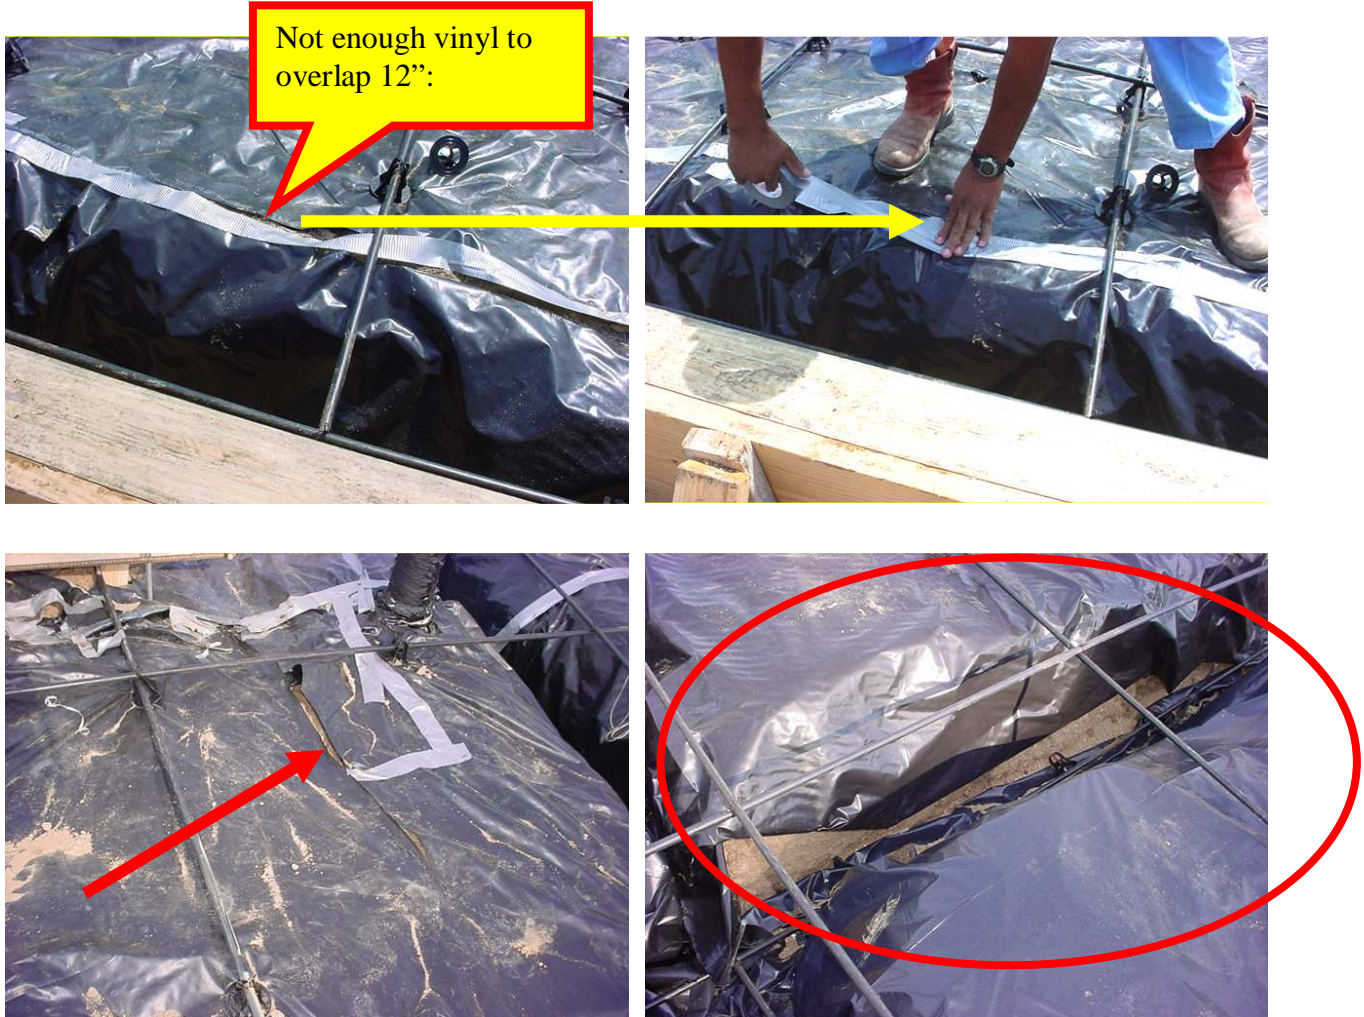
Details call for the foundation to have 6 mil vinyl under it for a moisture barrier. The vinyl is to be overlapped by 12 inches and taped in place. I found a number of areas where the soil was exposed and when I tried to have it fixed, it would not overlap by 12". These areas need repair.

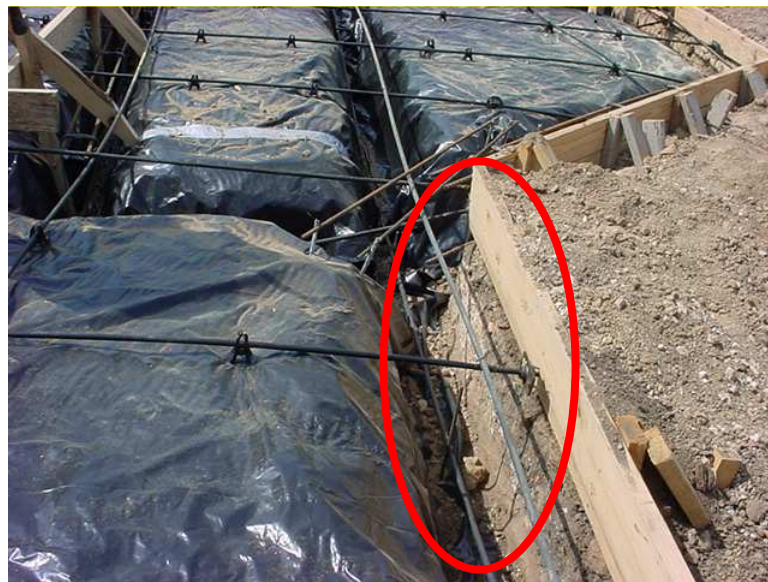
Forms are open on bottom in many areas. These will be closed prior to introduction of concrete.

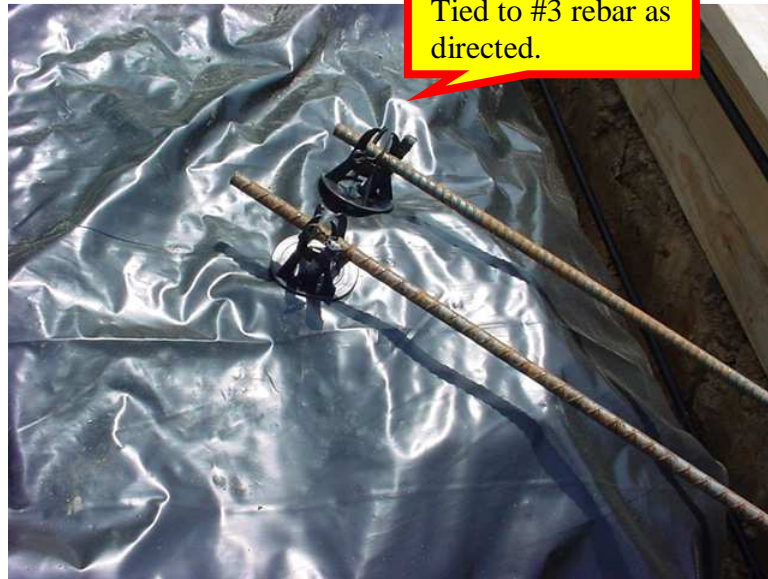
Corner bracing re-bar in southeast corner was not tied to foundation. This was corrected.
