### **1994 Sugar Land Home Inspection**

# ***PROPERTY INSPECTION REPORT***

**Concerning:** Sugarland, Texas m77479  
(Address or Other Identification of Inspected Property)

March 3, 2009  
(Date)

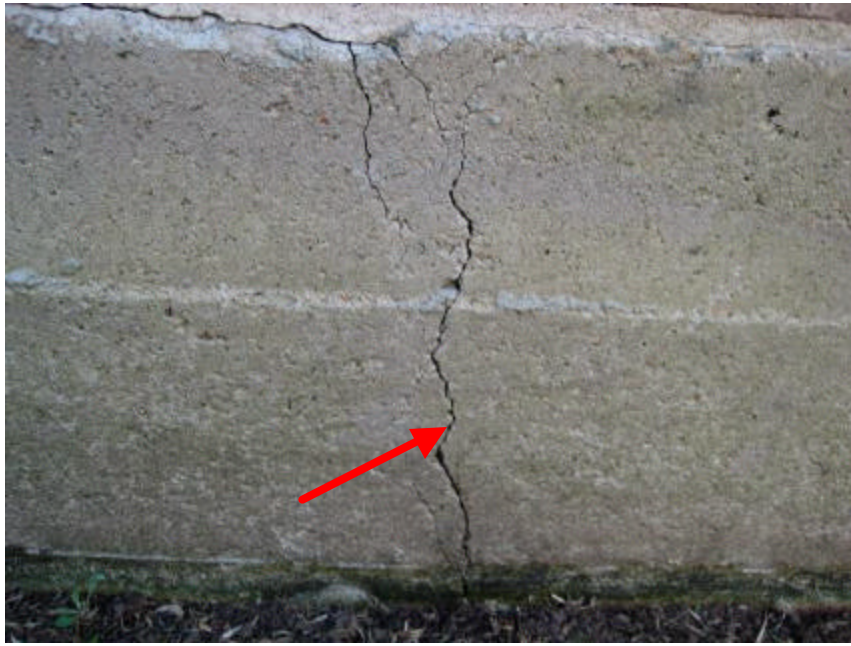
Foundation cracks observed on the north, and east side of the structure.

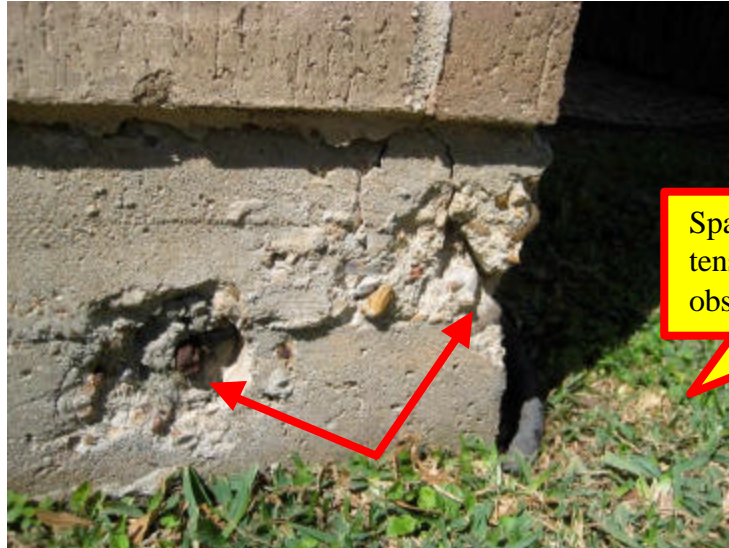
Post tension cable live ends are exposed, should be covered with non-shrink grout.  
Recommend repair before more extensive repairs become needed.

Spalling and exposed post tension end cables observed.

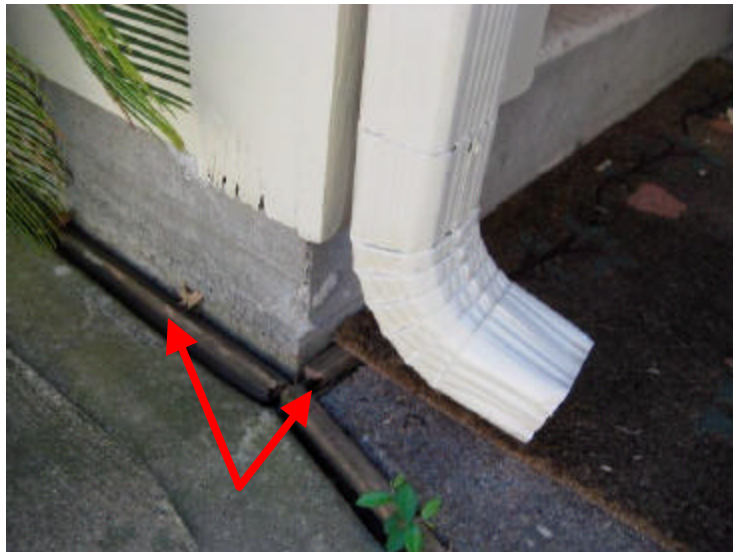
Wood form board(s) around foundation should be removed to reduce chance of wood destroying insect activity. (Garage area)

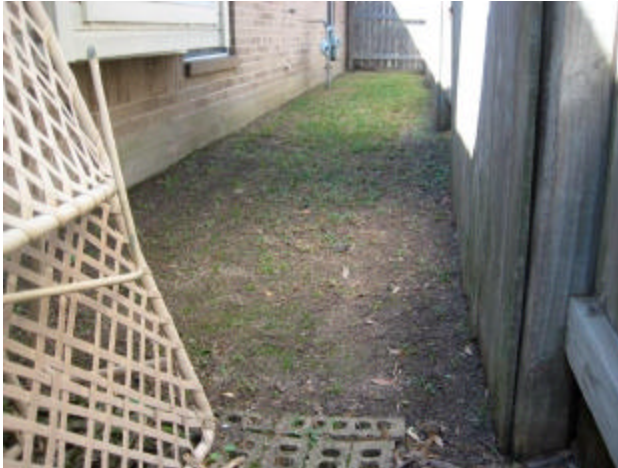
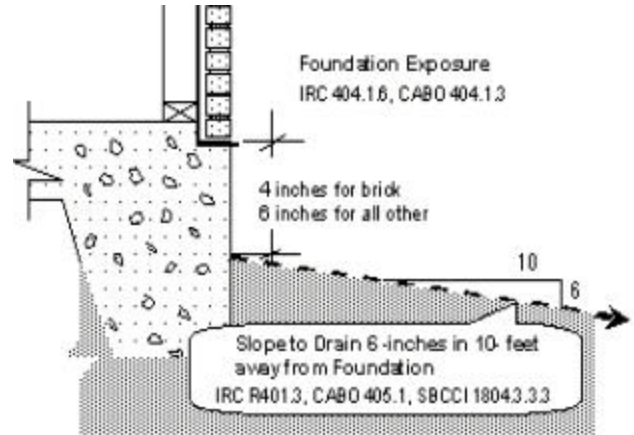
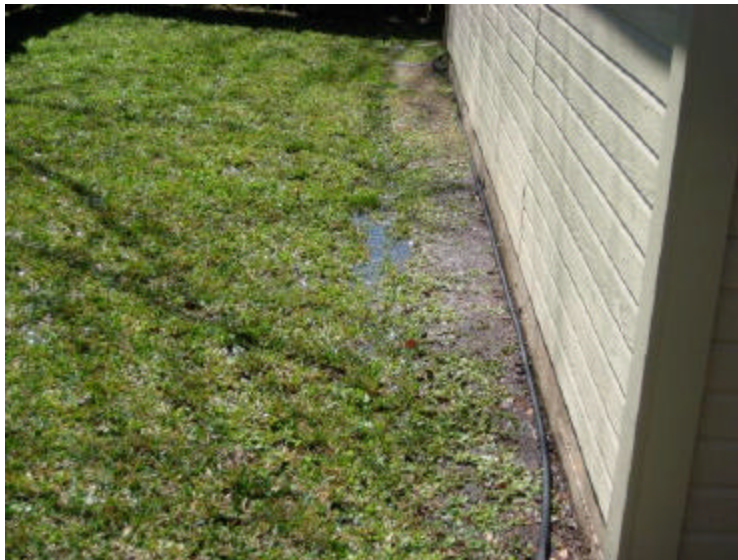
Soil grade and drainage patterns around some areas of house do not appear to properly direct water away from foundation to aid in controlling runoff water and could cause differential movement of the foundation or water penetration during heavy rains.

Soil level too high around areas with brick siding at North, east behind home and garage.

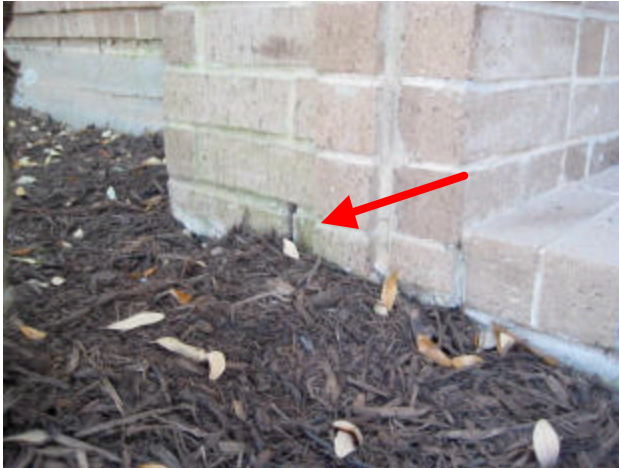
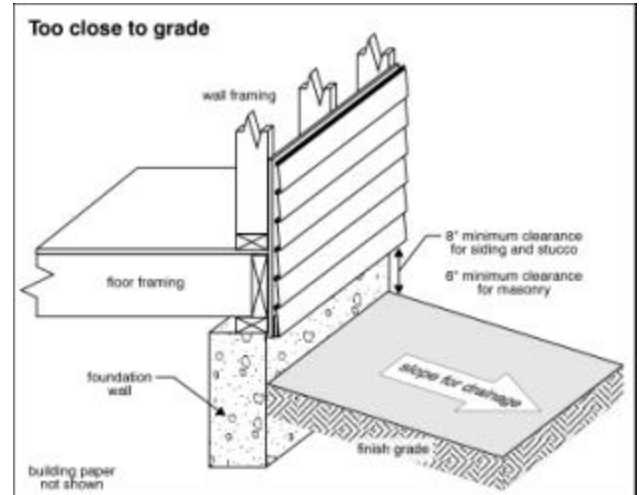
Common industry practice requires a clearance of at least 4 inches from bottom of brick veneer to soil. High soil level near brick siding promotes wood rot and is considered a conducive condition to termite activity and water penetration.

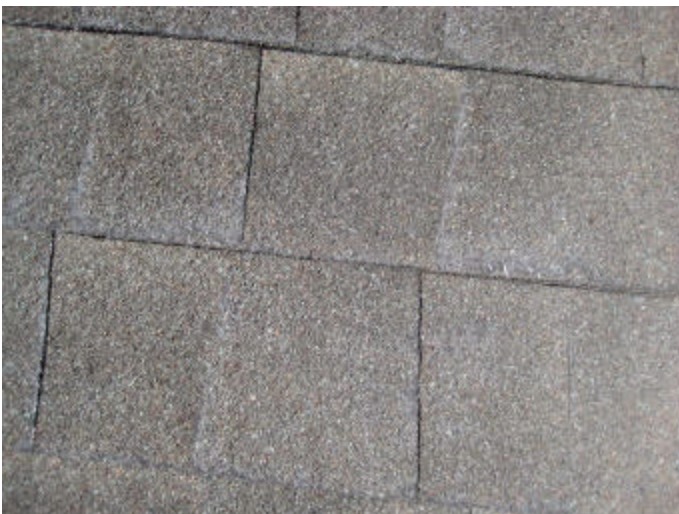
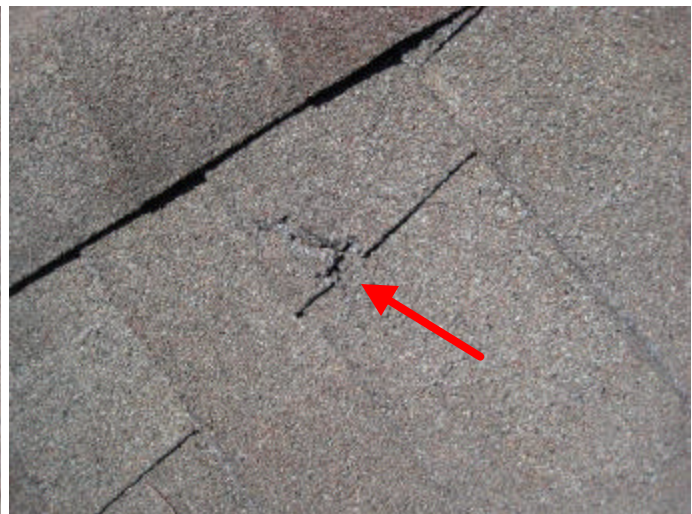
Older roof, nearing end (last 1/3 to 1/4 ) of serviceable life. Observed Brittle, cracked, curled ends, and/or granular loss of shingles.

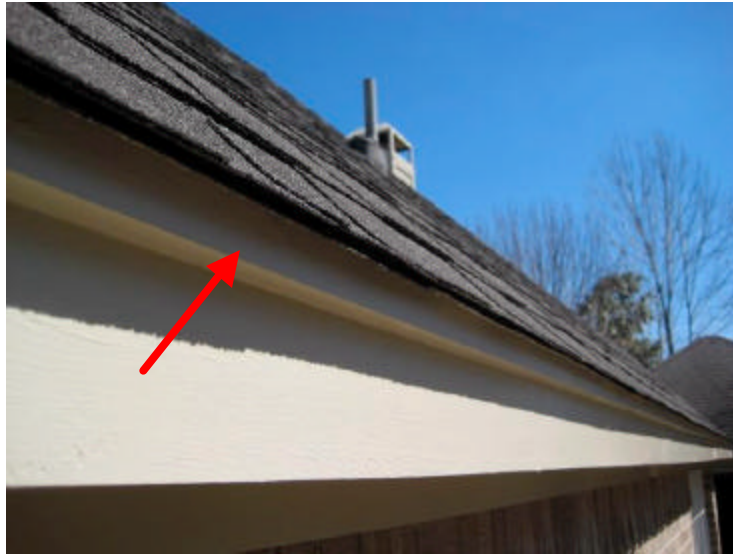
**VISIBLE FLASHING:**Observed rusted flashing;

No metal drip edge visible at roof edge. When drip edge is not installed, water dripping off of the edge of the roofing can be drawn by capillary action into the exposed edges of the plywood which can cause the plywood sheathing and fascia begin to rot..

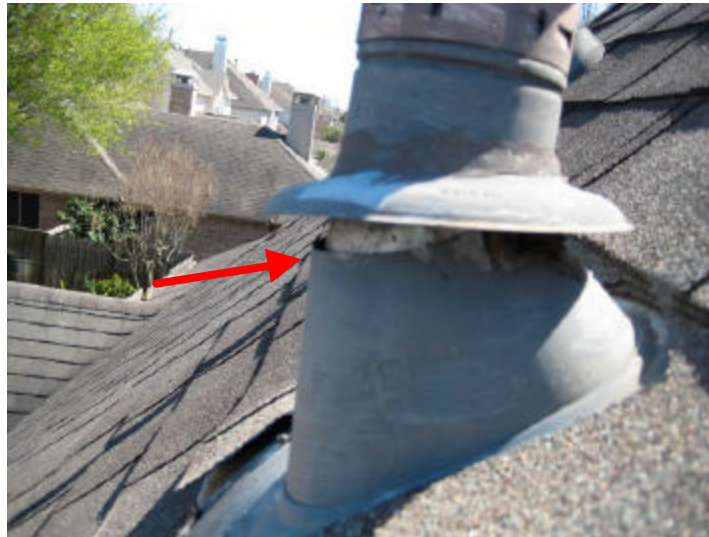
Storm collar not properly positioned on water and/or house heater vent pipe. Needs to be sealed to prevent wind driven rain from possibly entering the structure.

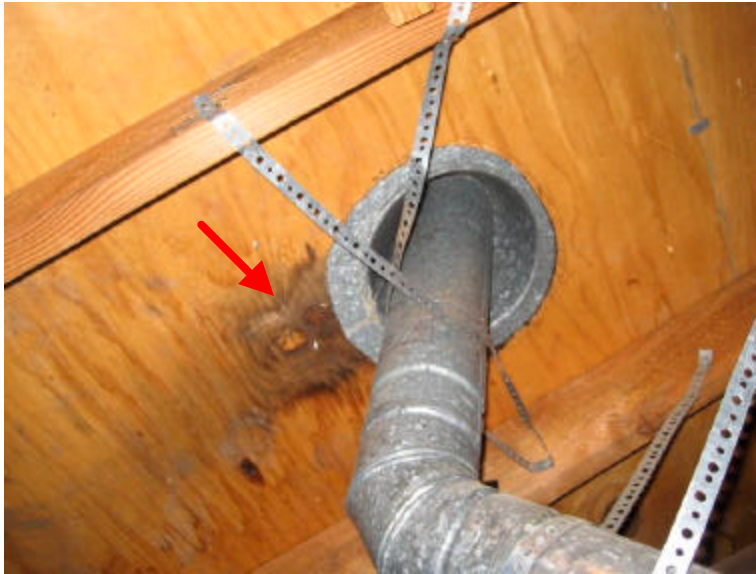
Possible from damaged areas of flashing on drain waste vents. (Old water stain observed under one of the heating unit flues.

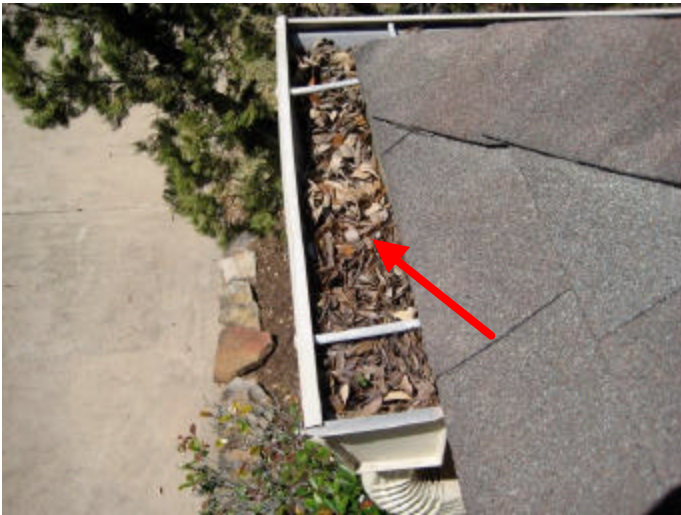
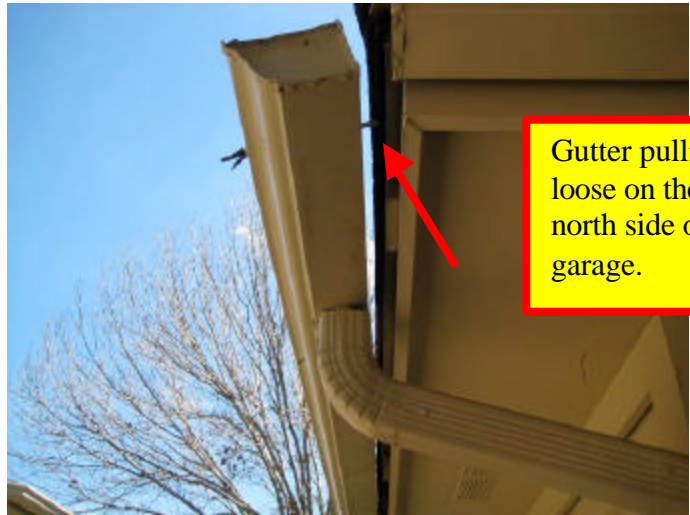
Gutter pulling loose on the north side of the garage.

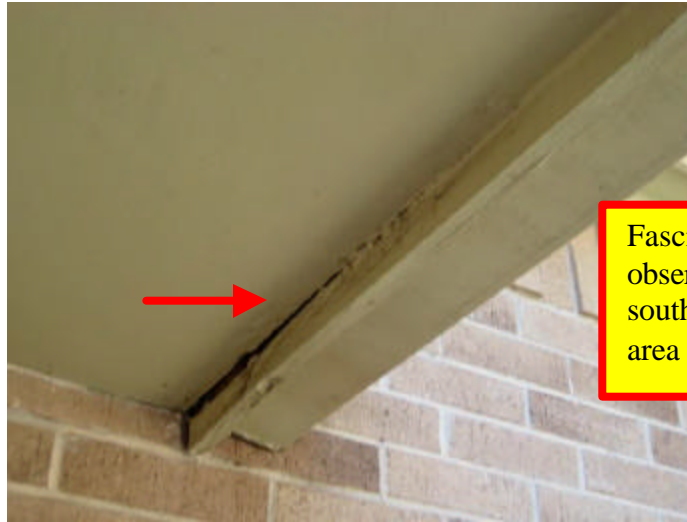
Observed water stains on fascia board on back side of rain gutters; indication water is running down back side of rain gutter which leads to wood rot.

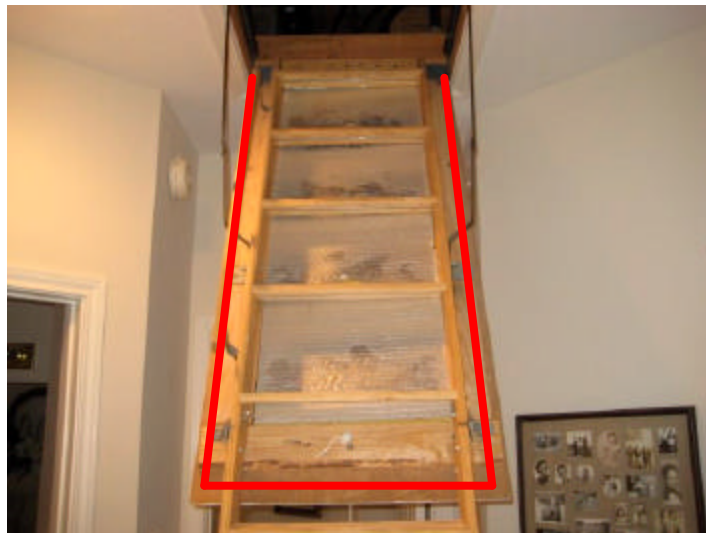
*Stairway to attic is not sealed, recommend client consider weather stripping to seal gaps and prevent loss of conditioned air to attic as well as insulating stairway if not done already.*

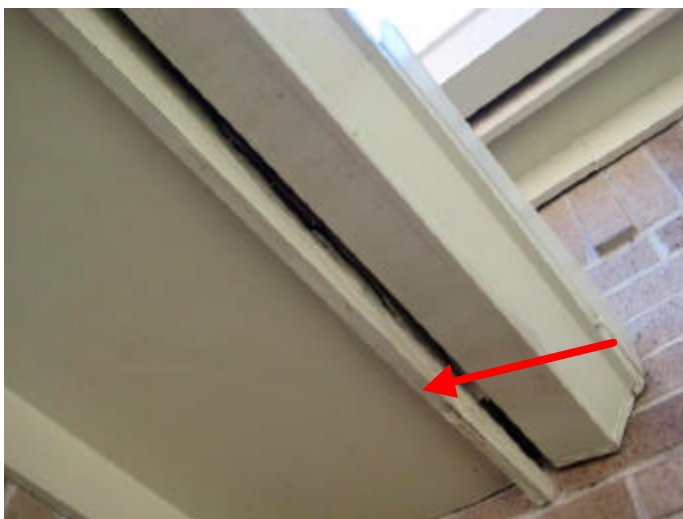
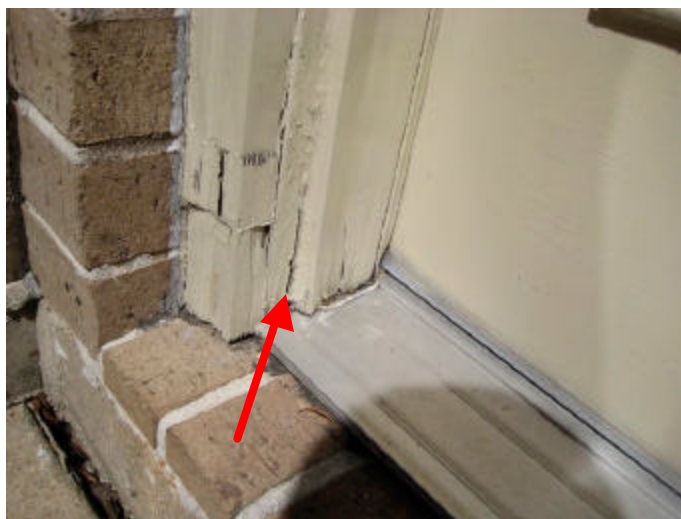
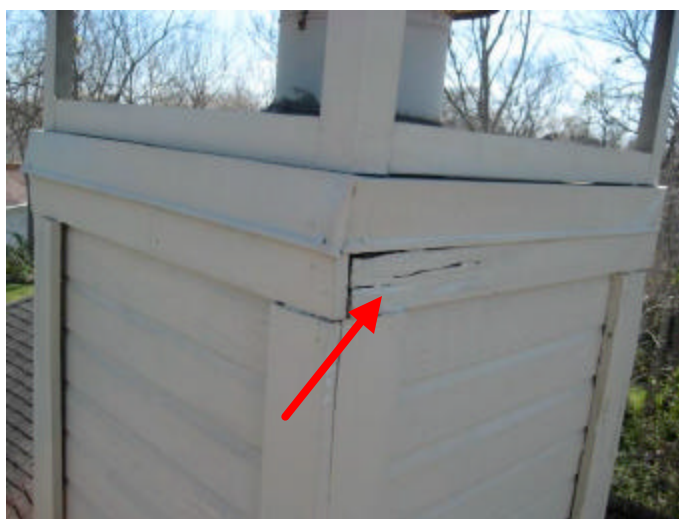
Wood rot observed on areas of house / garage.

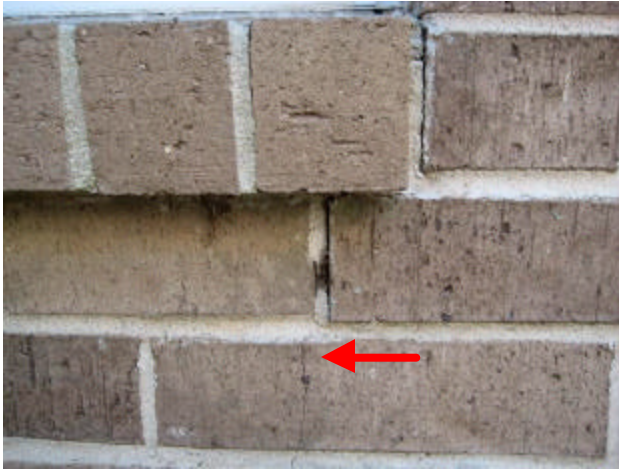
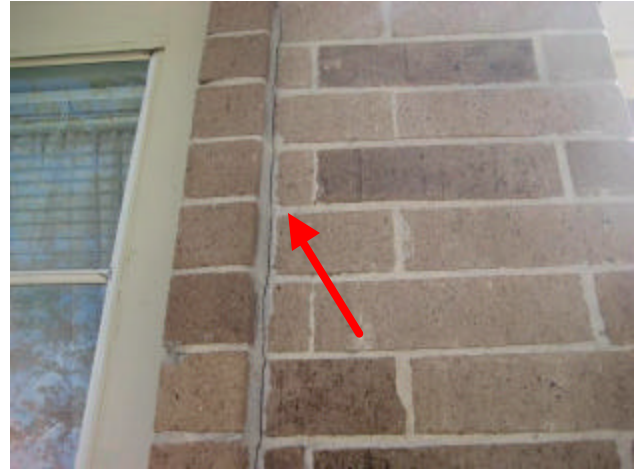
Cracks in brick veneer and/or repairs, one or more locations, Recommend buyer take photographs of cracks, their location, and width [ruler across the crack] with a high resolution camera that has a date stamp for future reference.

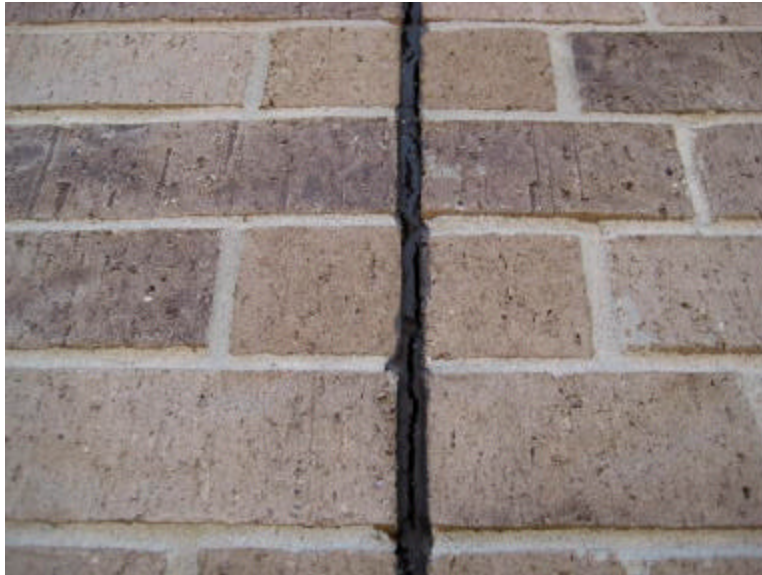
Expansion joint(s) and / or inside corners in brick veneer need re caulking. Ensure any mortar present in expansion joint is first removed before sealing.

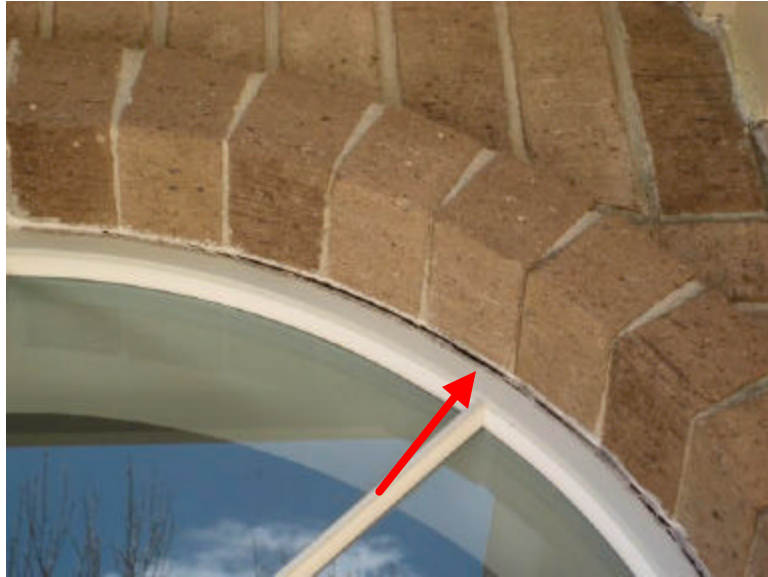
Caulking deficient around one or more windows, will allow water penetration during heavy / wind driven rains.

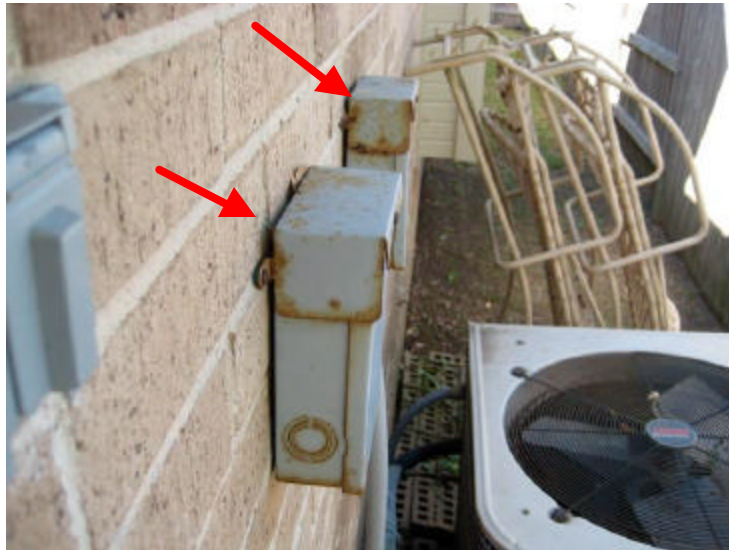
Recommend caulking around electrical disconnect box(s) of A/C unit(s) to prevent water entry behind disconnect(s).

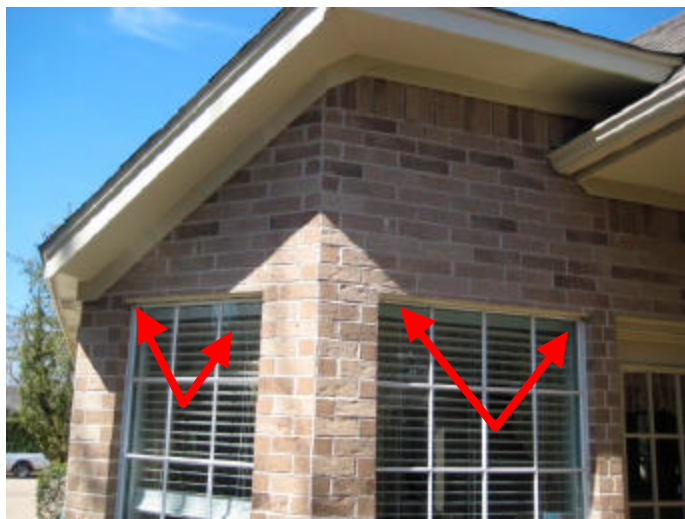
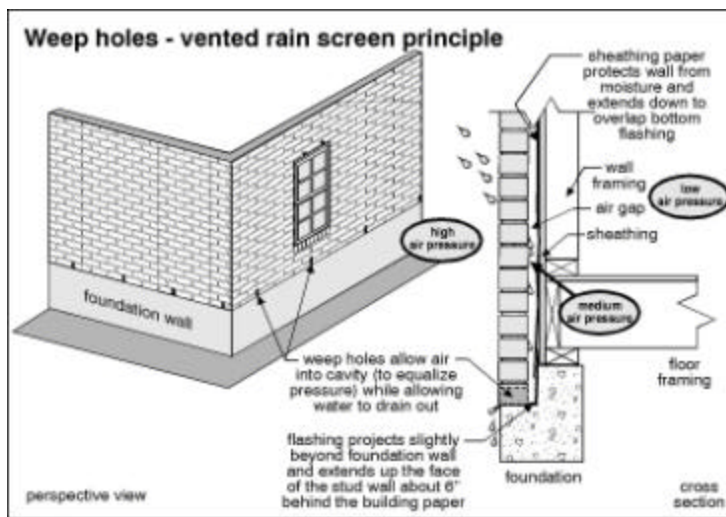
Brick veneer siding missing required weep holes to prevent moisture buildup in exterior walls and prevent wood rot / decay.

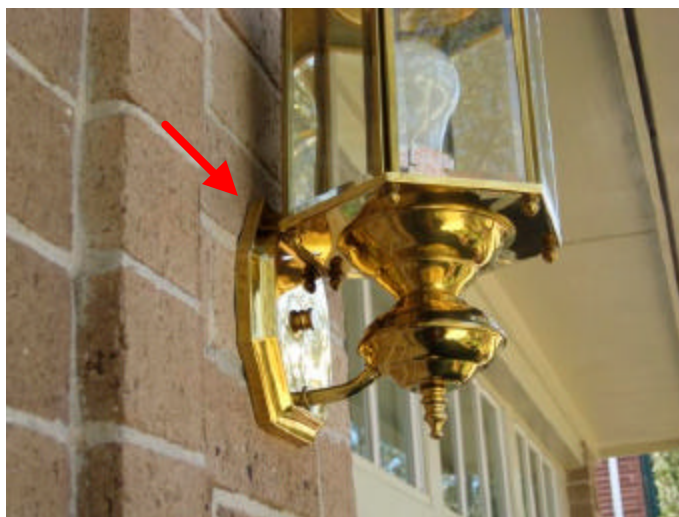
Need sealing / caulking around all holes and exterior siding penetrations on top and both sides, (leave bottom open) to prevent water entry. Including but not limited to dryer, bath and range top vents, light fixtures, etc.

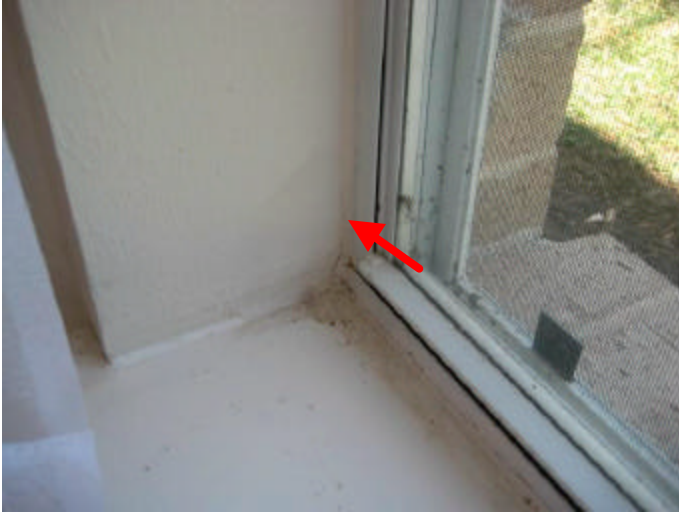
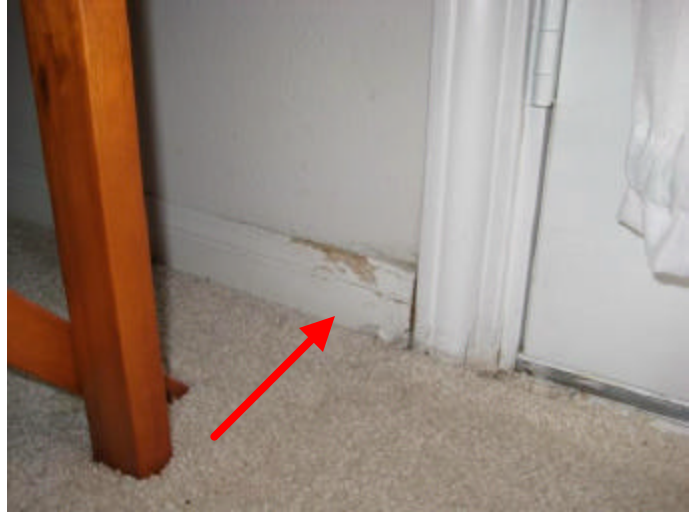
**YES !!**, Evidence of water intrusion observed from the master bedroom doors jambs and windows. Low moisture meter readings were taken at the time of this inspection at these areas.

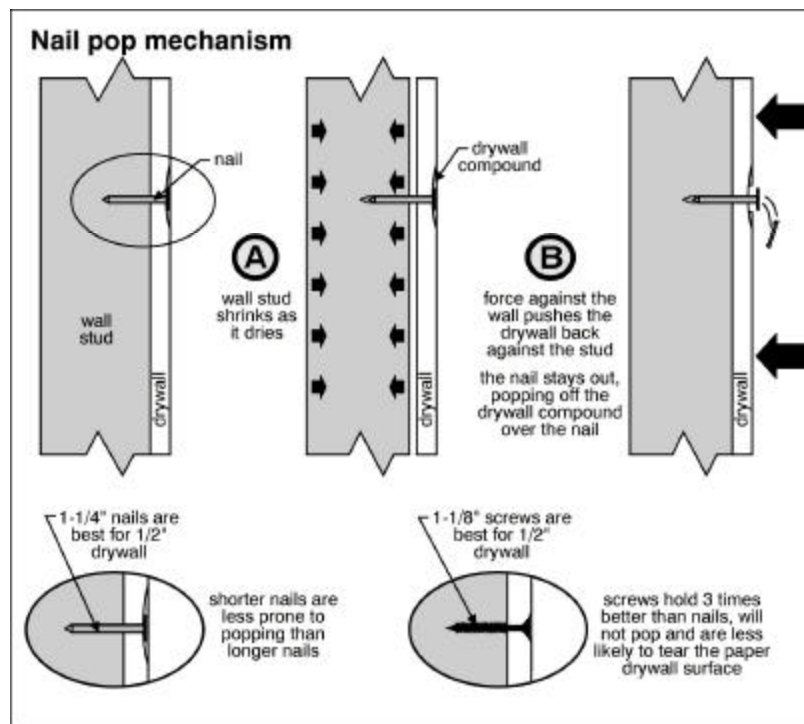
Ceiling cracks observed in the kitchen, and north middle bedroom area.

Nail pushing through the interior finish observed in the north middle bedroom, and master bathroom.

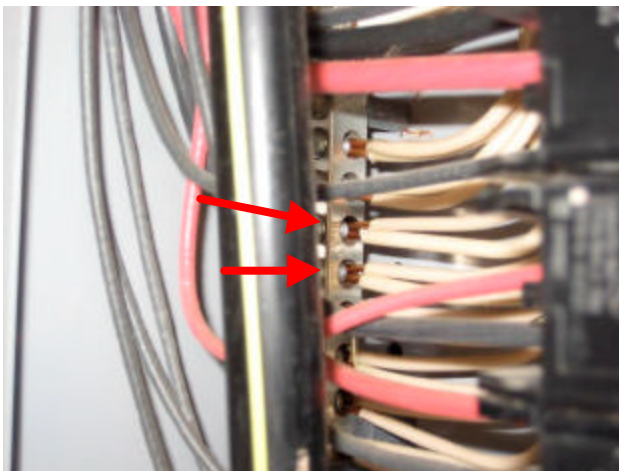
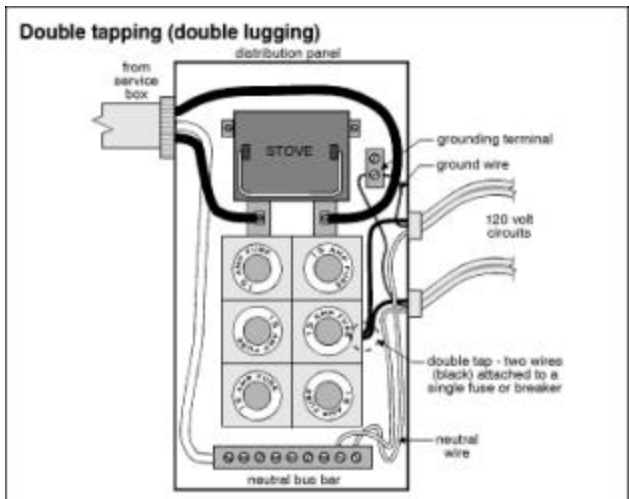
Double ganged neutral(s), [two wires improperly on 1 lug] observed.

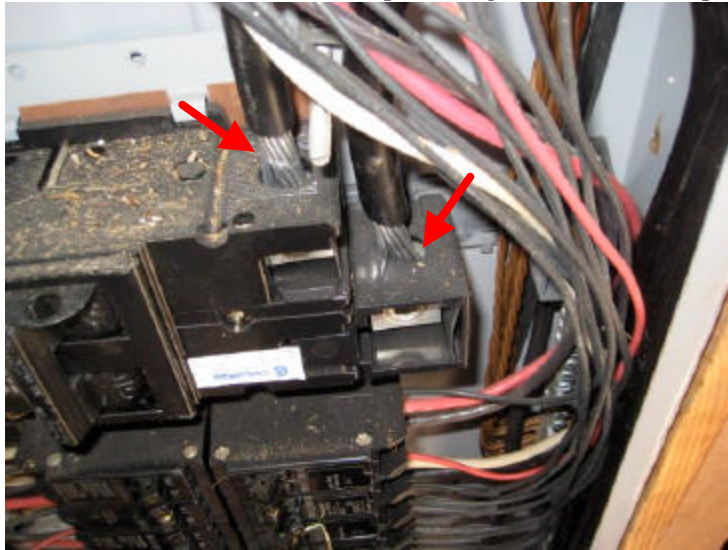
*Did not observe anti-oxidant compound (grease) on the exposed aluminum feeder wiring.*

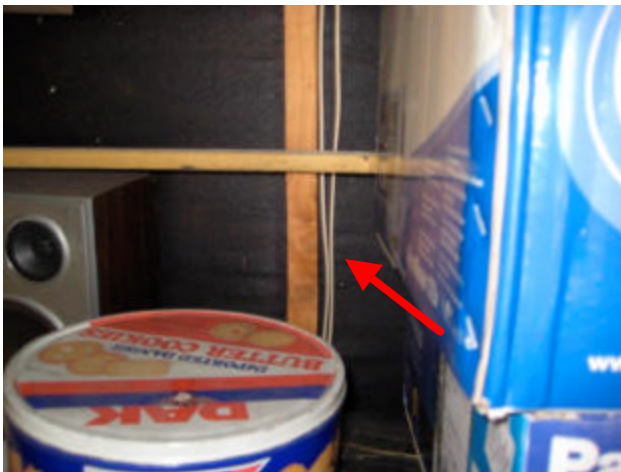
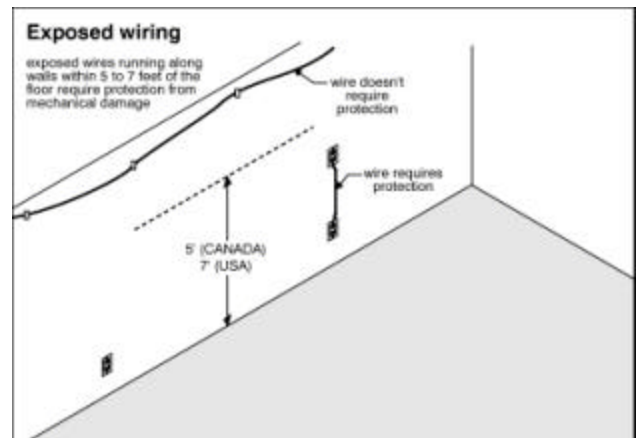
Electrical wiring not in protective conduit;

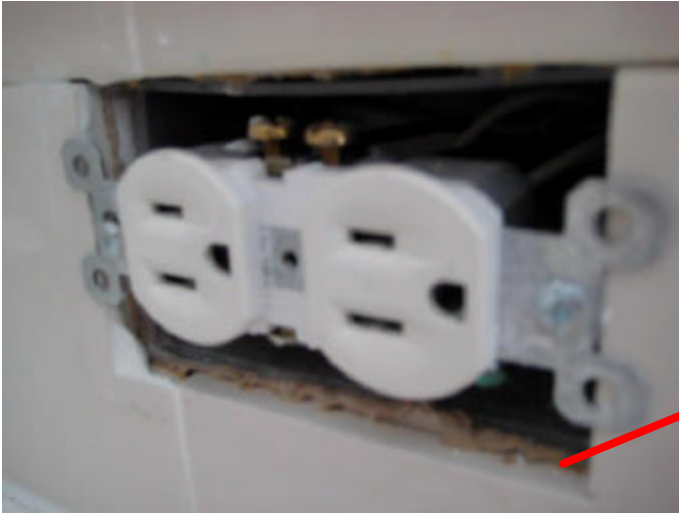
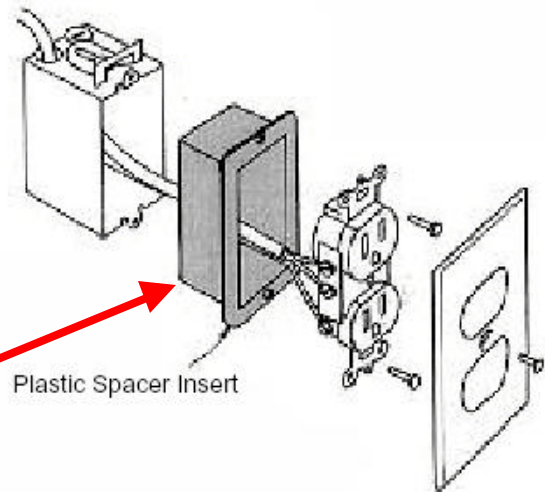
Space between face plate and edge of electrical junction box exceeds ¼ inch allowable by code. Missing required spacer ( spark ring) on all kitchen / bath counter top outlets and switches with tile back splash. Reference NEC 370-20 & IRC E3806.5. In walls of concrete, tile or other noncombustible material, cabinets (outlet & switch boxes) and panel boards shall be installed so that the front edge of the cabinet will not set back of the finished surface more than 0.25 inch.

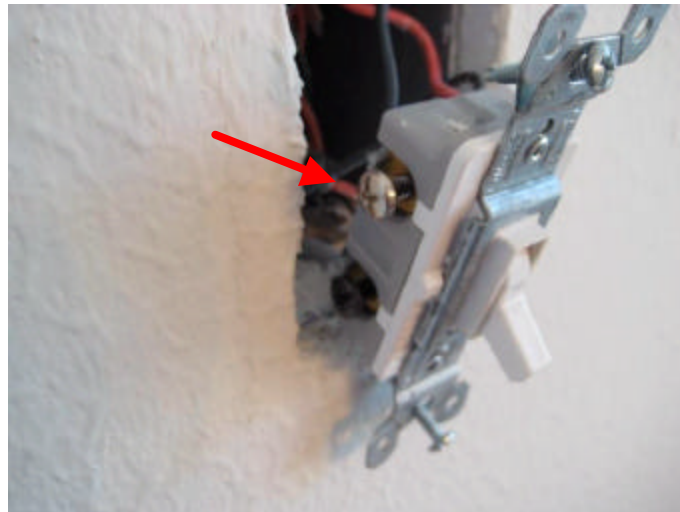
*Voltage detector indicated switch(s) are not grounded as required by current industry standards (code) to reduce risk of electrical shock. Prior to 1999, grounding of switches was required. Recommend grounding all non-grounded switches or replace all metal face plates and screws with non-conductive plastic face plates and screws.*

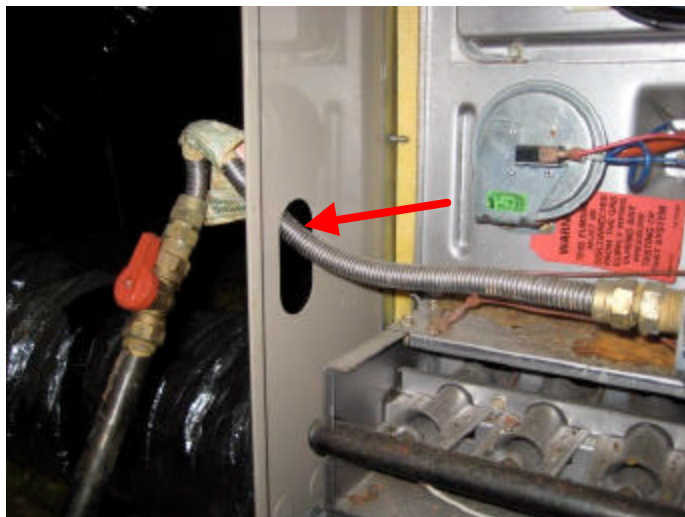
Flexible gas line is not allowed by current industry standards and most installation instructions to pass into metal cabinet of gas heating units due to vibration from unit can rub hole in gas line, rigid metal pipe should extend outside cabinet a minimum of 2 inches for flex line connection.

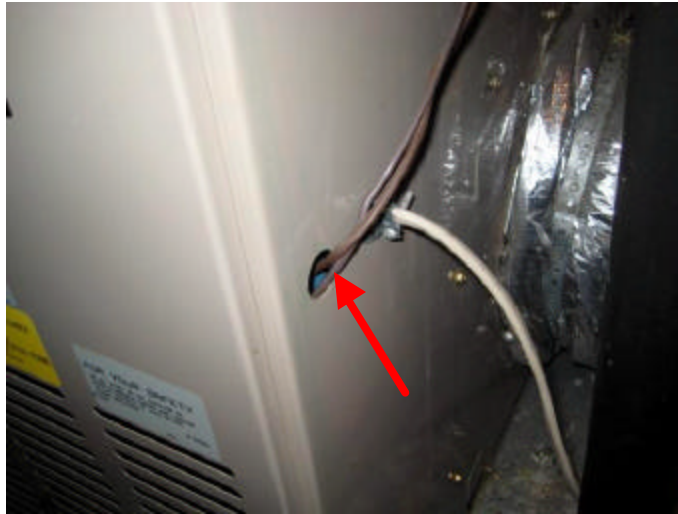
Thermostat wiring not secured to attic unit(s), missing small fitting that secures wiring to cabinet to prevent pulling loose by service personnel or homeowner.

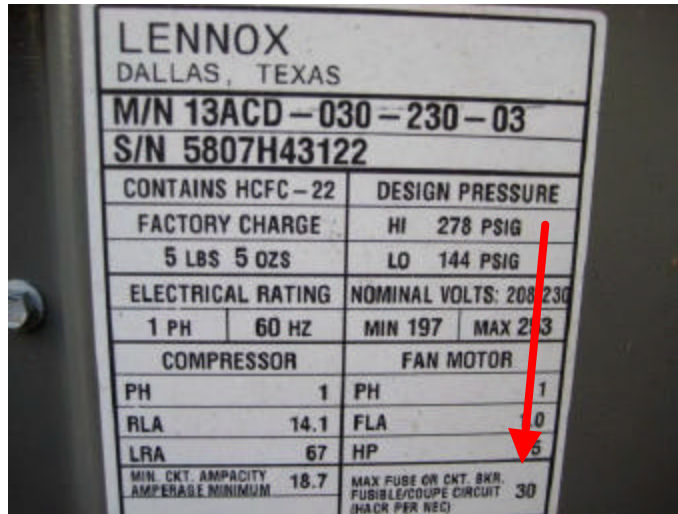
Improper sizing of breaker to unit may void manufacture's warranty. Data plate on unit states maximum breaker size to be 30 amps, observed size in service panel is 40 amps.

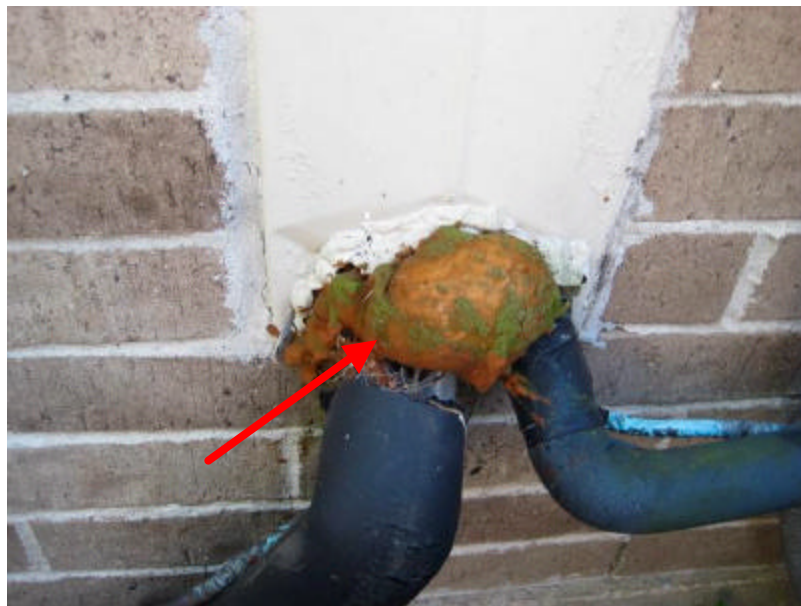
*Recommend painting expanding foam sealant where A/C Freon lines pass through wall to protect it from degradation due to UV light exposure.*

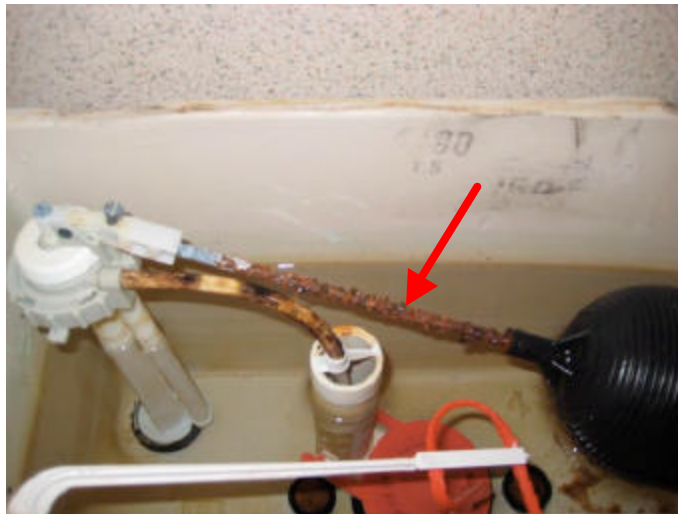
**WATER SUPPLY PLUMBING:***Water supply piping observed to be predominantly plastic.**Water softener, treatment and filtration type equipment is not checked / inspected.***COMMODOES:**Float arm observed to be rusted to the hall bathroom.

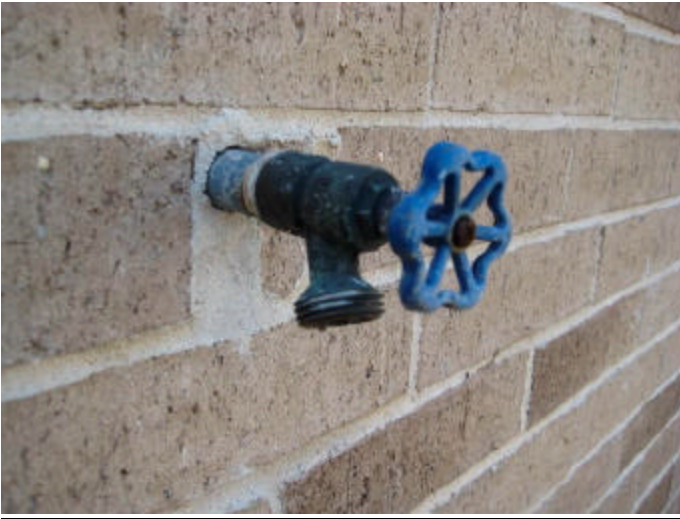
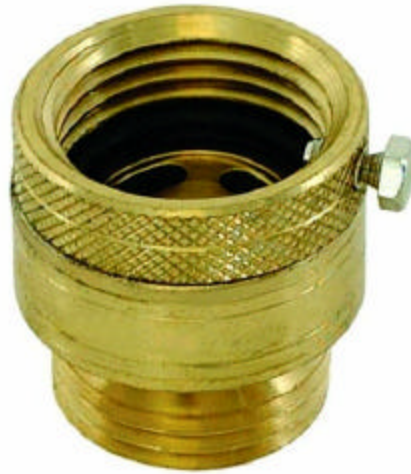
Exterior hose spigot(s) do not have code approved anti-back flow devices installed.

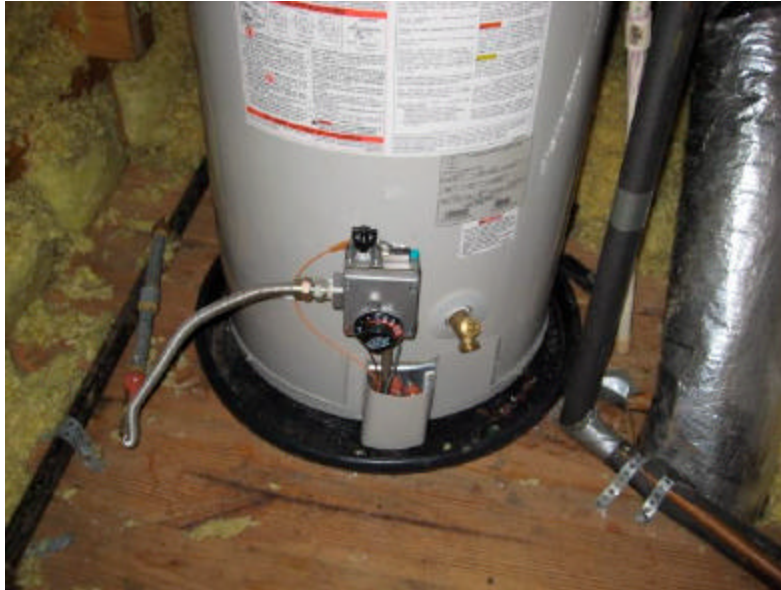
**Gas water heater drain pan is improper material;** *is sitting in a plastic safety pan, should be a metal pan. REF: 1991 Standard Plumbing Code 1213.7.1 IRC 2801.5 which states, " When water heaters are installed in such areas that leakage could cause water damage to the building or injury to occupants, the tank shall rest in a galvanized steel or other metal pan of equal corrosive resistance have a thickness at least equal to 0.0276-inch (24 gauge) galvanized sheet metal. EXCEPTION: Electric water heaters may rest in a high impact plastic pan of at least 1/16 inch thickness."*

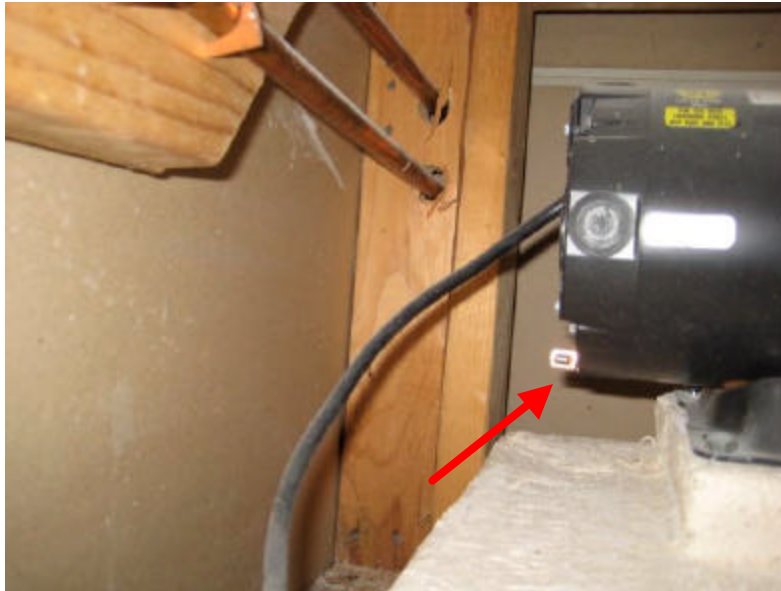
Spa tub motor not properly bonded (wire) from motor to cold water line as required by National Electric Code (NEC 680-41) and manufacture of spa IRC 4109.4.

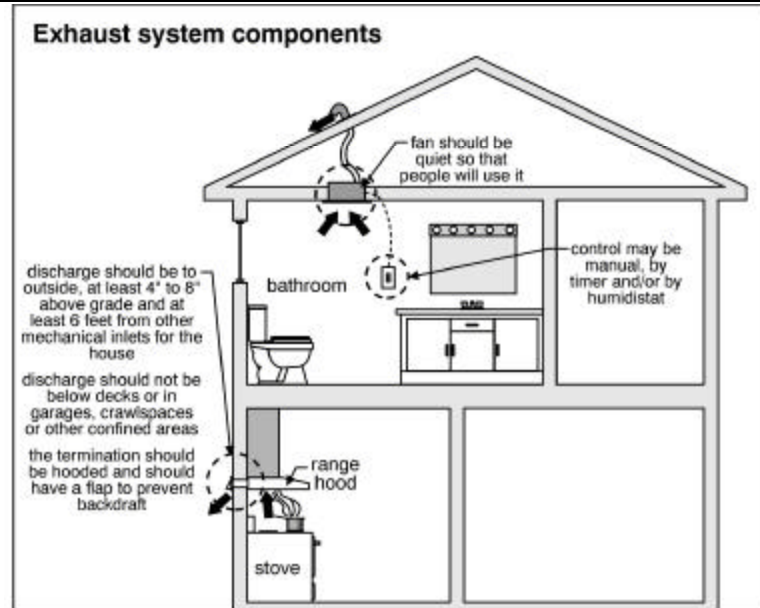
Improperly vents into attic. Should vent to exterior.

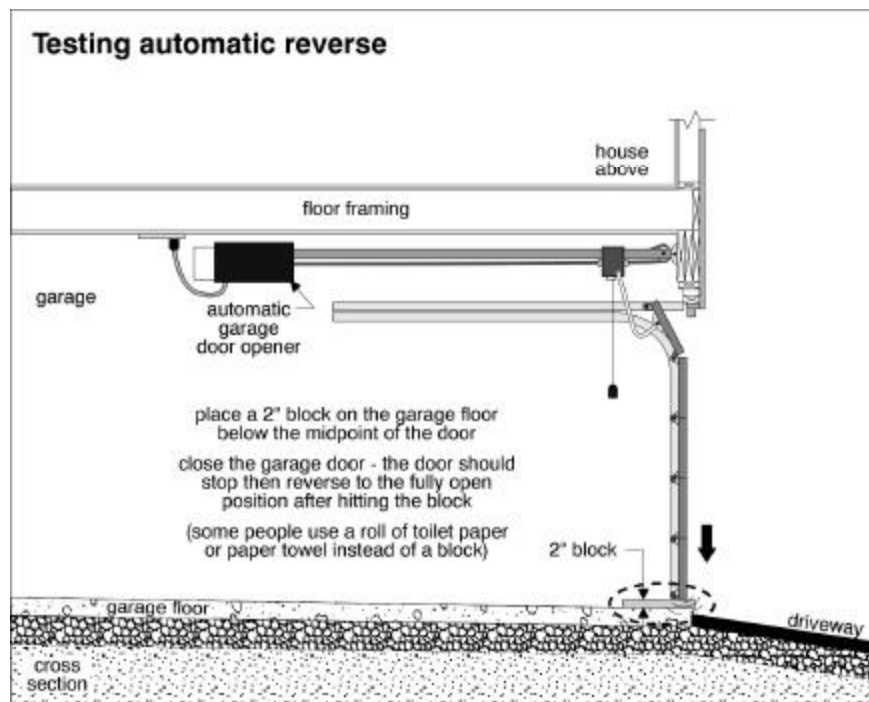
Garage door did not automatically reverse itself when it closed onto a 2x4 test block.

Door opener reversing switch [if it has one] needs adjustment so that it will open the door if it strikes an object.

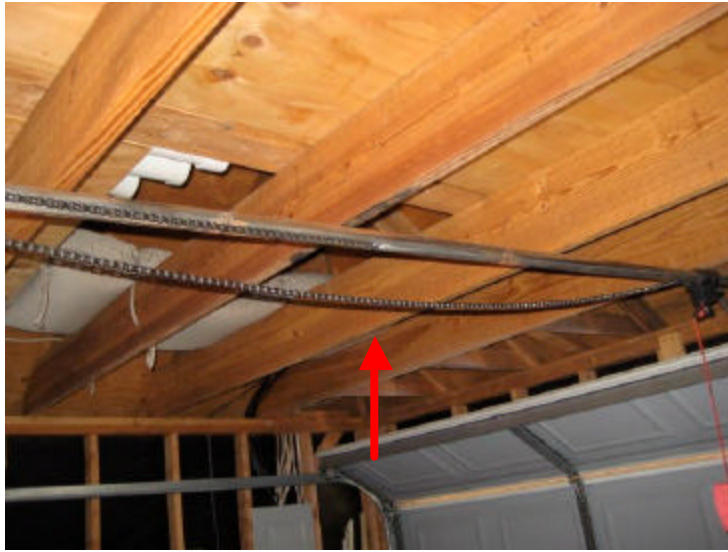
Unit has excessive vibration / noise level; recommend lubrication.

Drive chain loose, recommend adjustment.

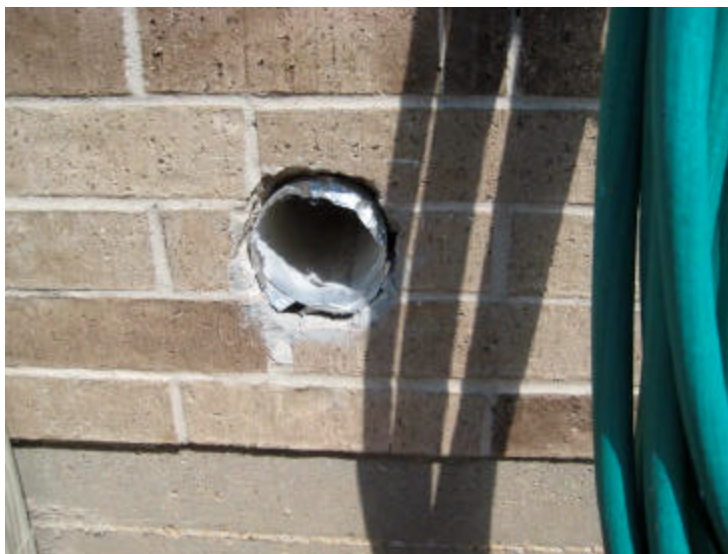
Exterior dryer vent cover observed to be missing.

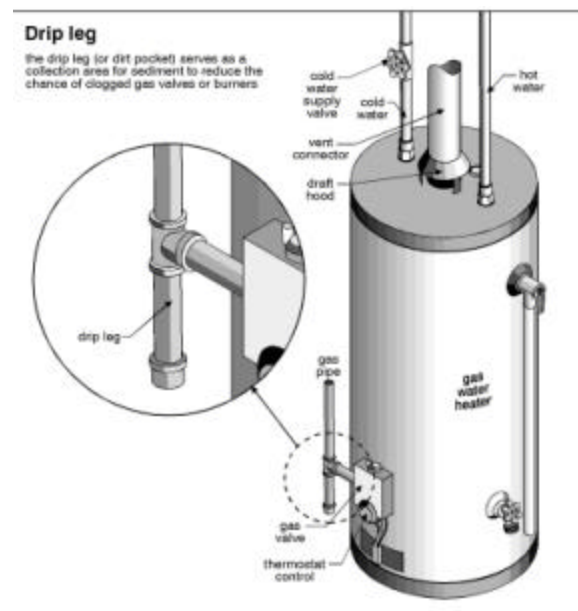
*Proper flex.**Did not observe gas line drip leg(s) on gas house heater and/or gas water heaters which is called for in the manufactures installation instructions.*

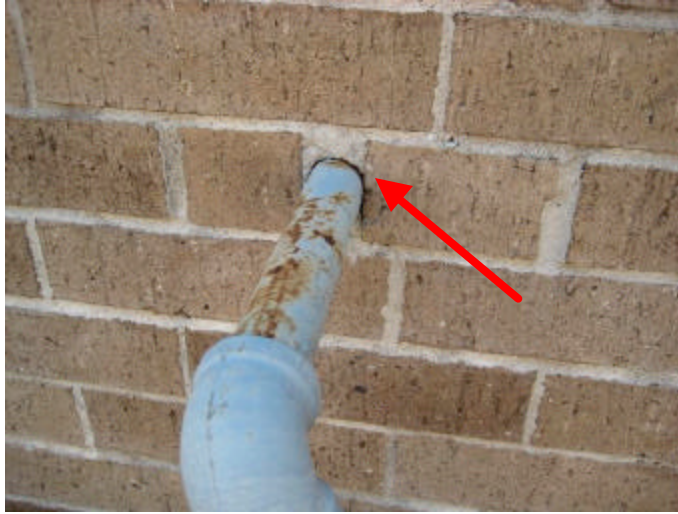
Gas piping not sleeved as it passes thru masonry wall as required by Code [CABO 2608.3] IRC 2603.3.
