### **1994 Sugar Land Home Inspection**

# ***PROPERTY INSPECTION REPORT***

**Concerning:** Sugarland, Texas m77479  
(Address or Other Identification of Inspected Property)

March 3, 2009  
(Date)

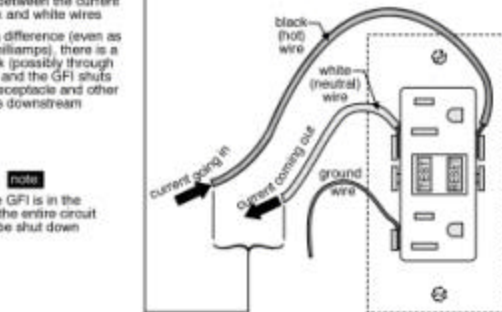
One or more outlets are not secured well in wall, those identified were marked with red dots on cover screws. (Exterior outlets)
